**CERTIFICATION REPORT  
EXPLOSIVE GAS MONITORING PROBE  
MP-10 ABANDONMENT  
ST. BERNARD LANDFILL**

**Village of St. Bernard**

April 23, 2018

File No. 23212007.06

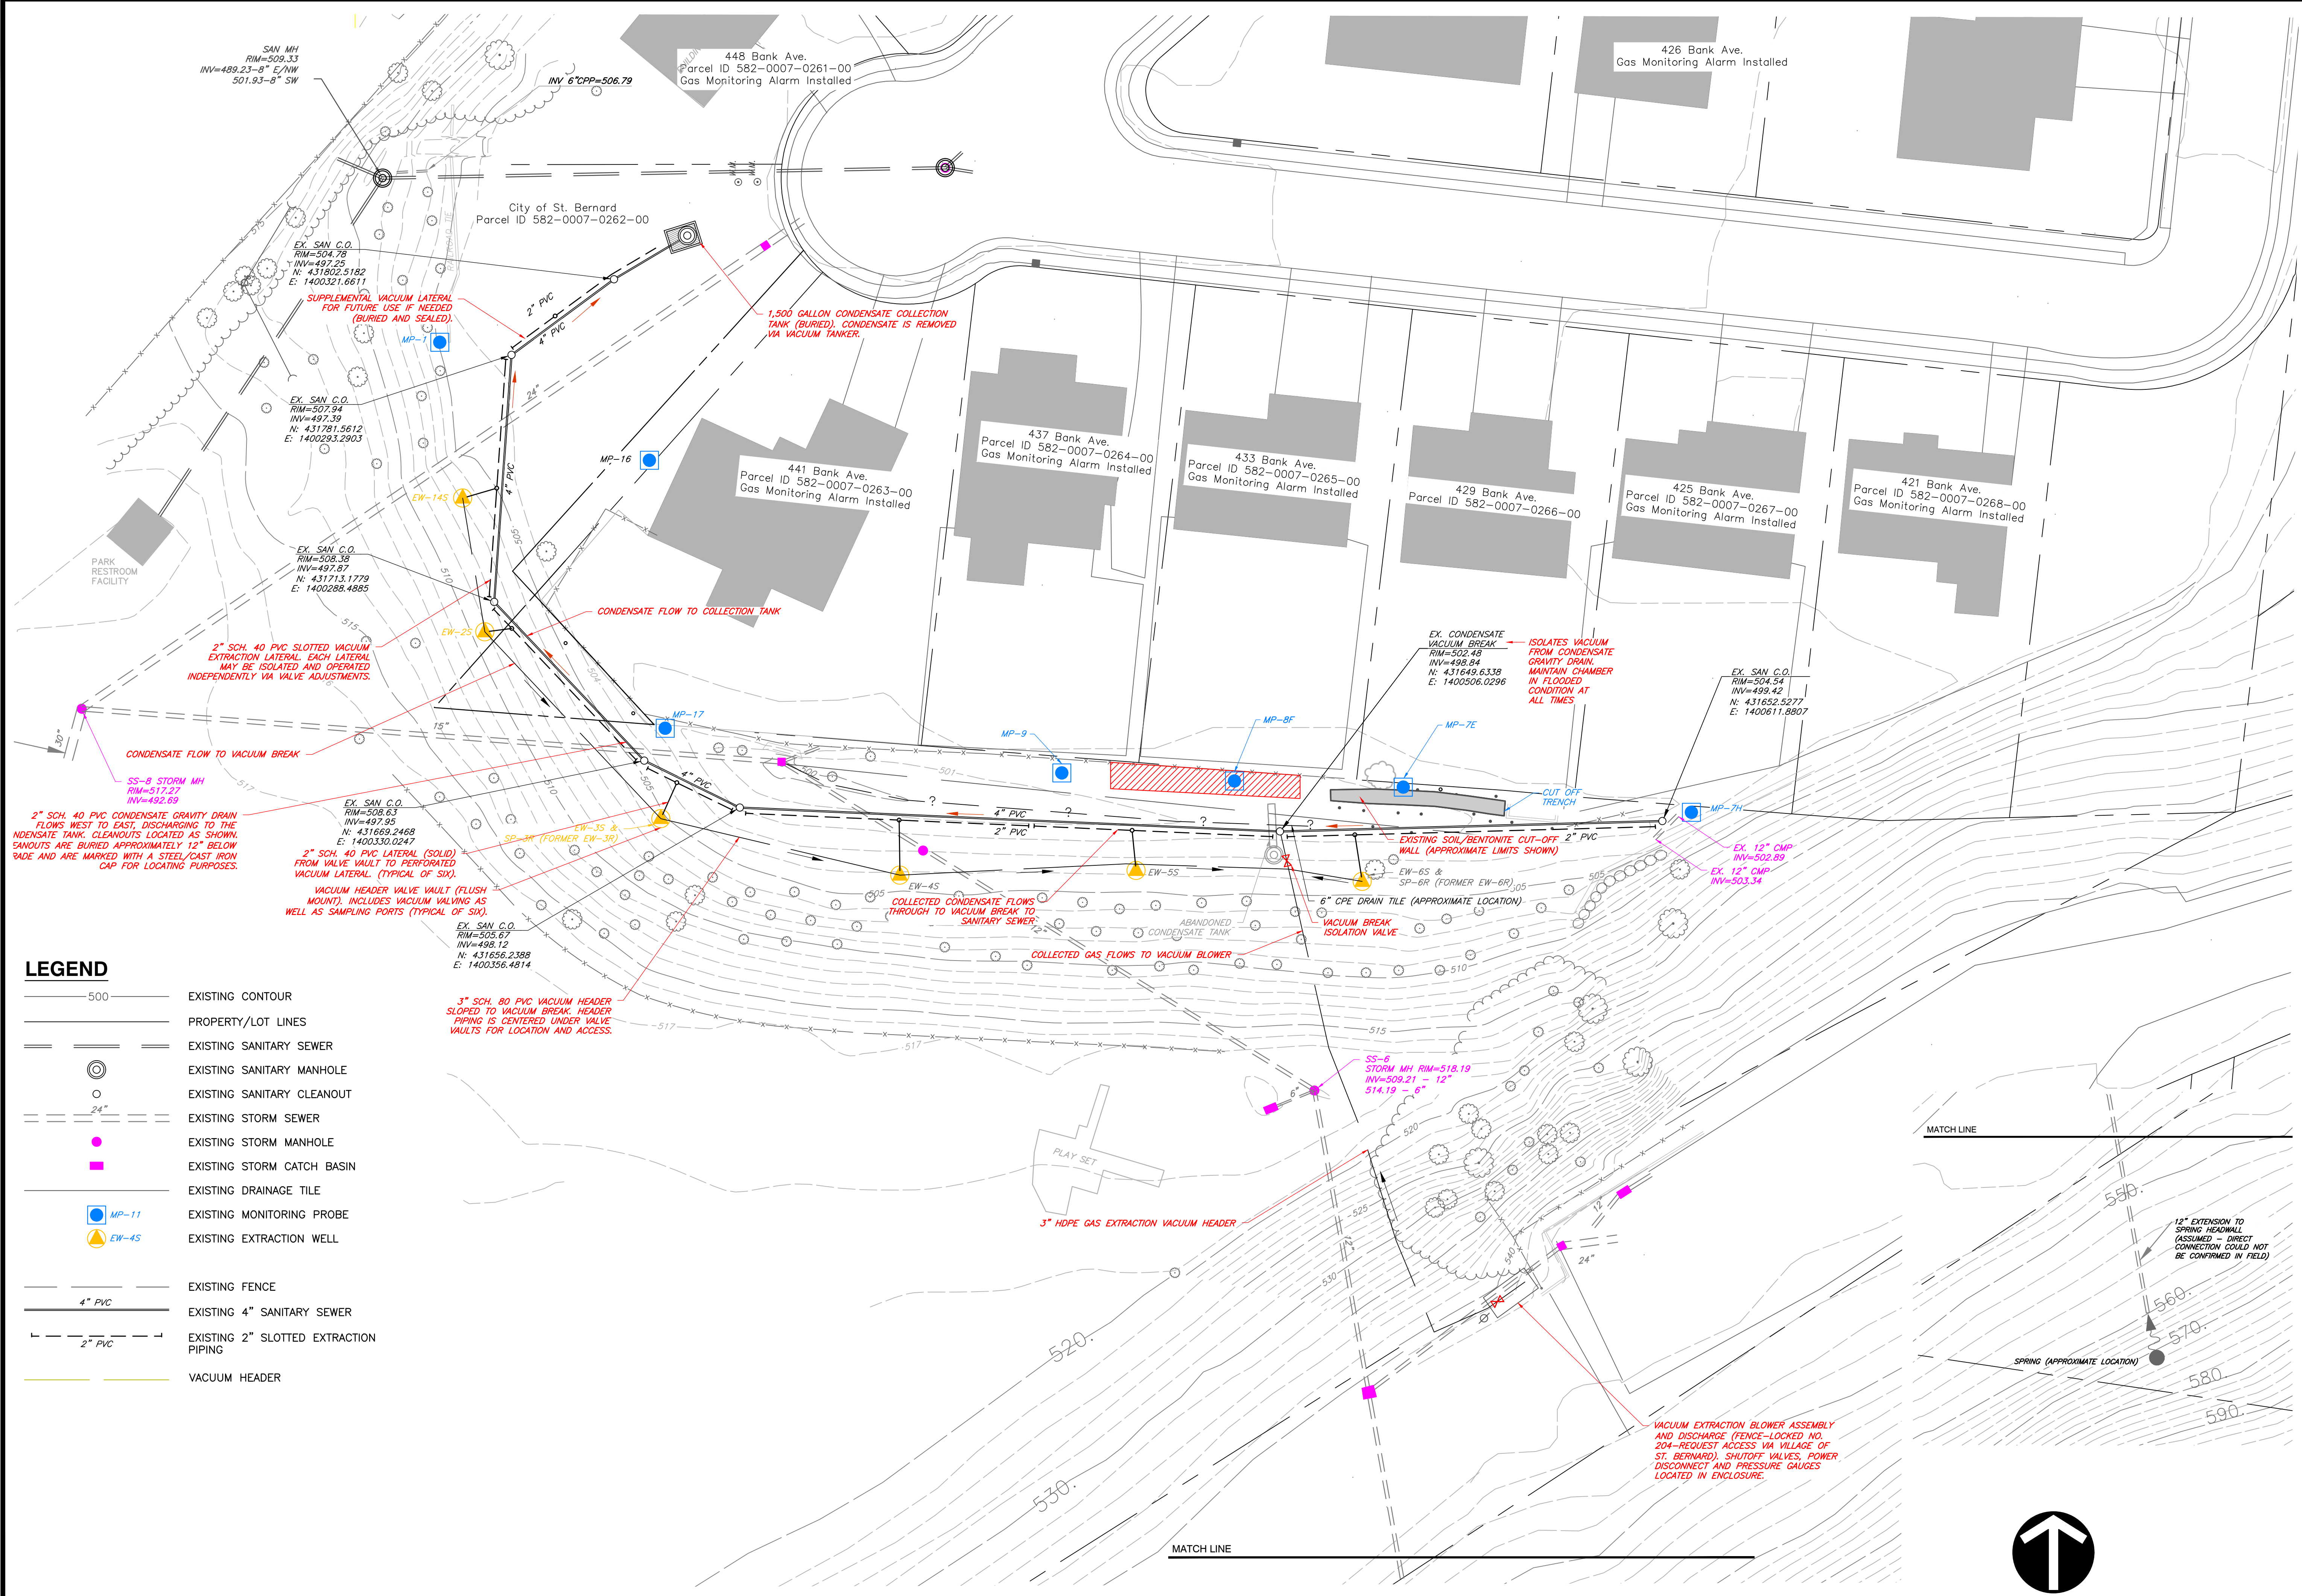
APPENDIX C  
EGMP FIGURE 4

The explosive gas permanent monitors referenced in this report were abandoned in compliance with the EGMP, as revised in June 2015, and with the OAC Rule 3745-27-12. The enclosed Figure 4 shows the locations of the current network of explosive gas monitors for the St. Bernard Landfill following the abandonment of MP-10.

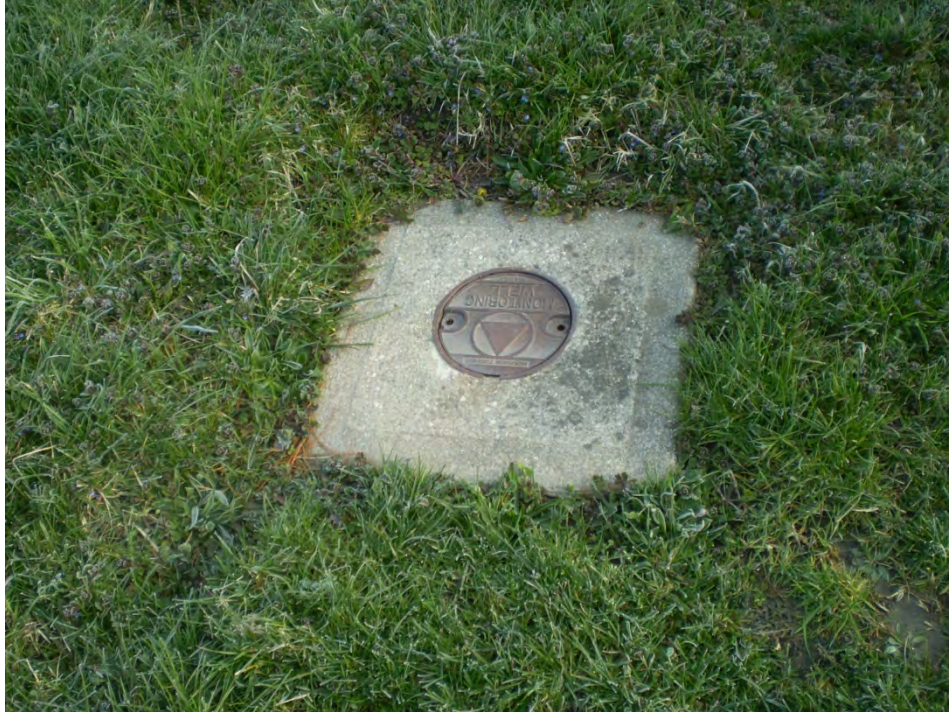
Photo 1. MP-10 flush mount protective casing.

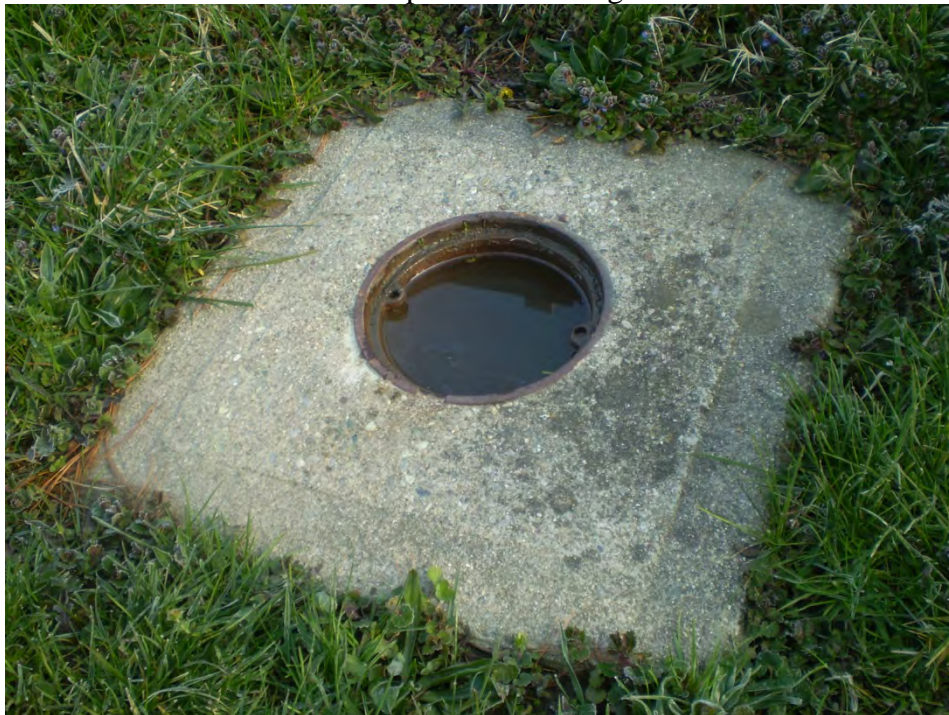
Photo 2. MP-10 with lid removed.

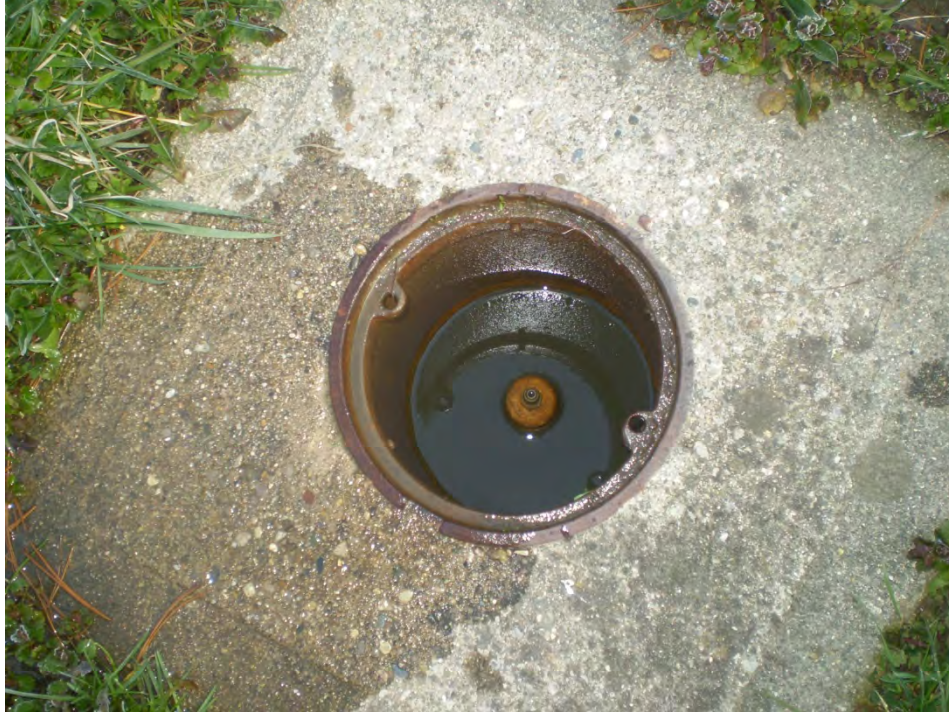
Photo 3. MP-10 bailed to expose cap and quick connect.

- The protective casing was opened and the probe number was confirmed.
- The casing was carefully filled with bentonite chips. The bentonite chips were added so as to avoid introducing fines that could potentially cause bridging at the water surface.

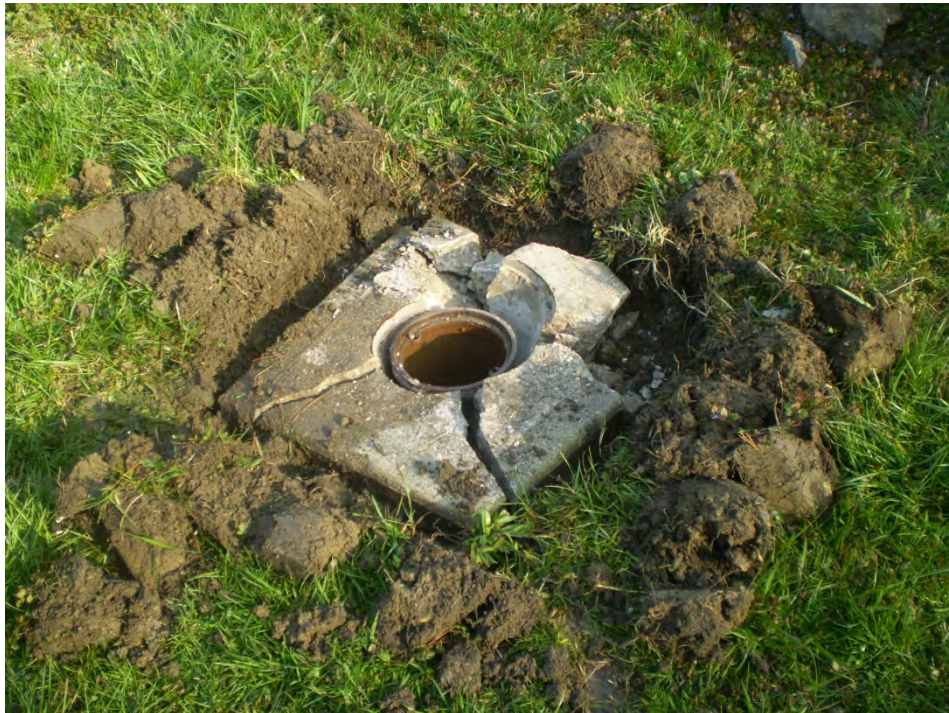
Photo 4. Concrete pad broken and in process of removal.

- The concrete pad was manually broken and removed along with the flush mount protective casing. The probe casing disconnected from the screen in this process.

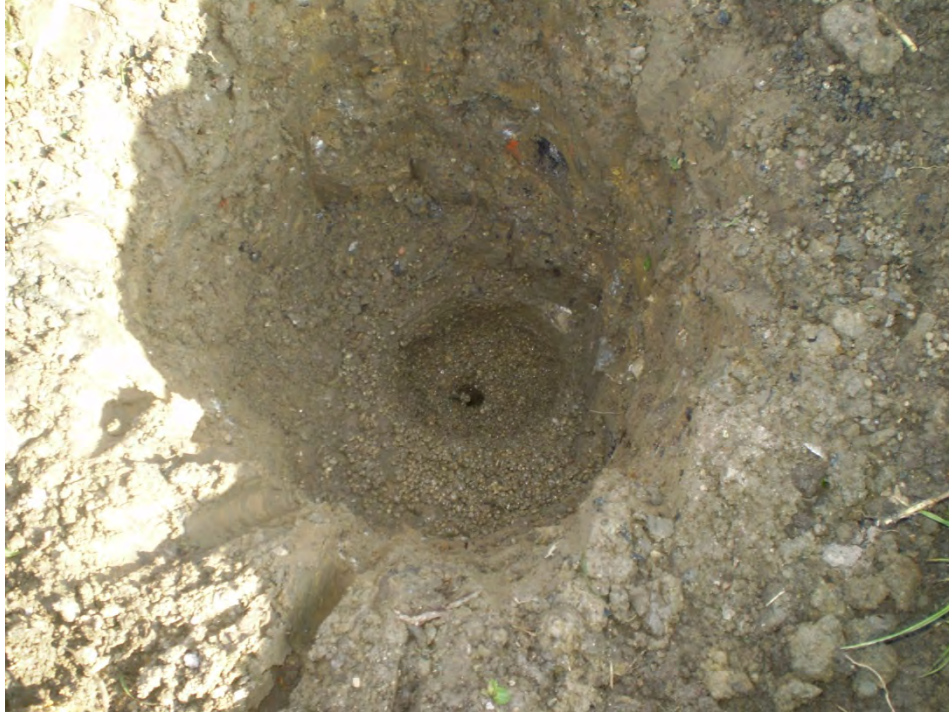
Photo 5. MP-10 excavated to 3 feet with screen removed.

- The screen was removed while excavating to the three foot target depth. The remaining hole was filled with bentonite.
- The annular seal was removed excavating to three feet, therefore a foot of bentonite chips was placed in the excavation. Water was added to hydrate the bentonite.

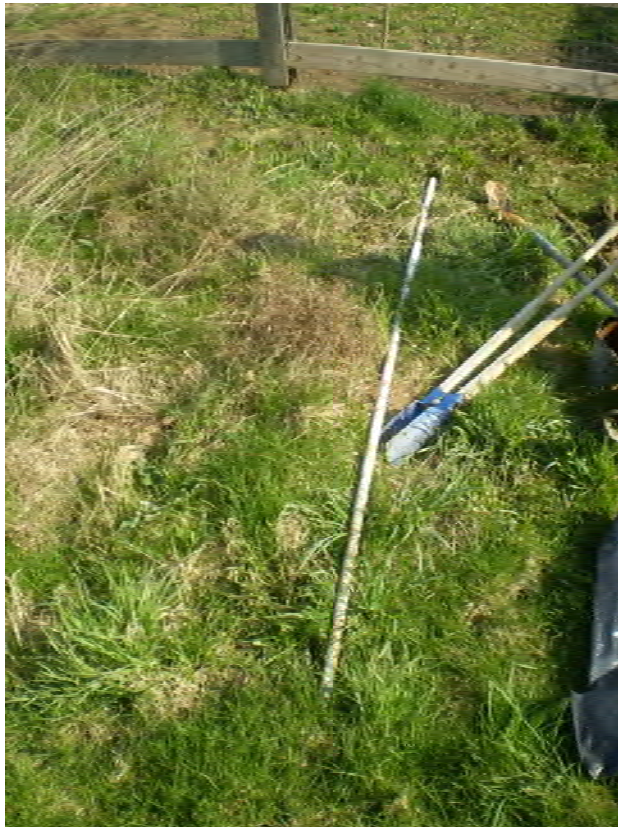
Photo 6. Screen removed from MP-10.

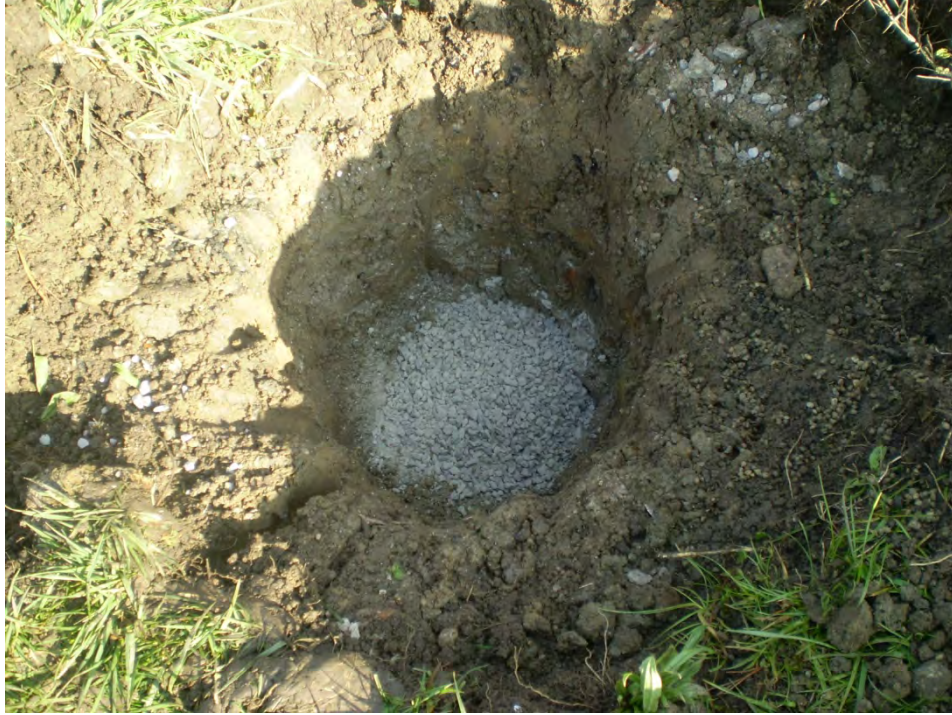
Photo 7. One foot of bentonite placed, prior to hydration.

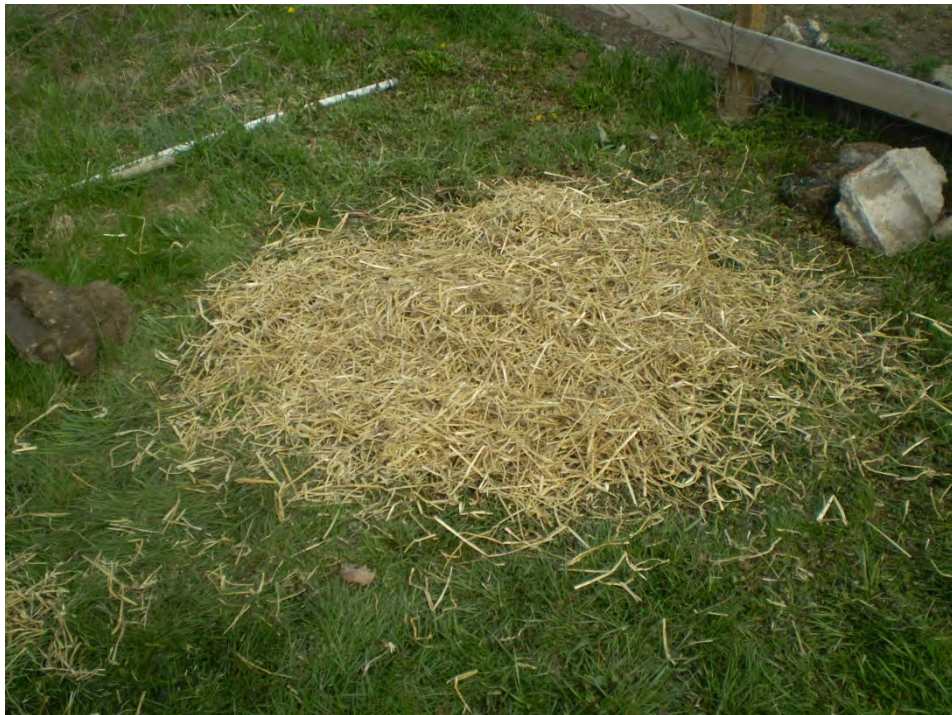
Photo 8. Backfill, seeding, and mulching completed.

- The remaining hole made when the protective casing was removed was backfilled with the soil excavated. Clean fill soil was then added as required to return the surface to grade. The areas of disturbed soil were seeded and mulched with straw to reestablish grass in the area.

All soils removed were used to backfill the excavation. The concrete pad, protective casing, and the probe casing and screen were disposed of as construction and demolition debris at an approved facility. Clean topsoil was used to fill any remaining depression and to provide improved growing conditions for grass. The soil was mounded slightly over the center of the excavation in anticipation of minor settlement. Grass seed was applied and the topsoil and seed were covered with loose straw. Photos of the excavated area after the placement of straw are included in Appendix D. Further settlement, if it occurs, will be addressed by the Village as needed.
