SCS ENGINEERS

August 9, 2017
File No. 23212007.05

Subject: Village of St. Bernard Landfill
MP-10 2nd Contingency Monitoring 30-day Report

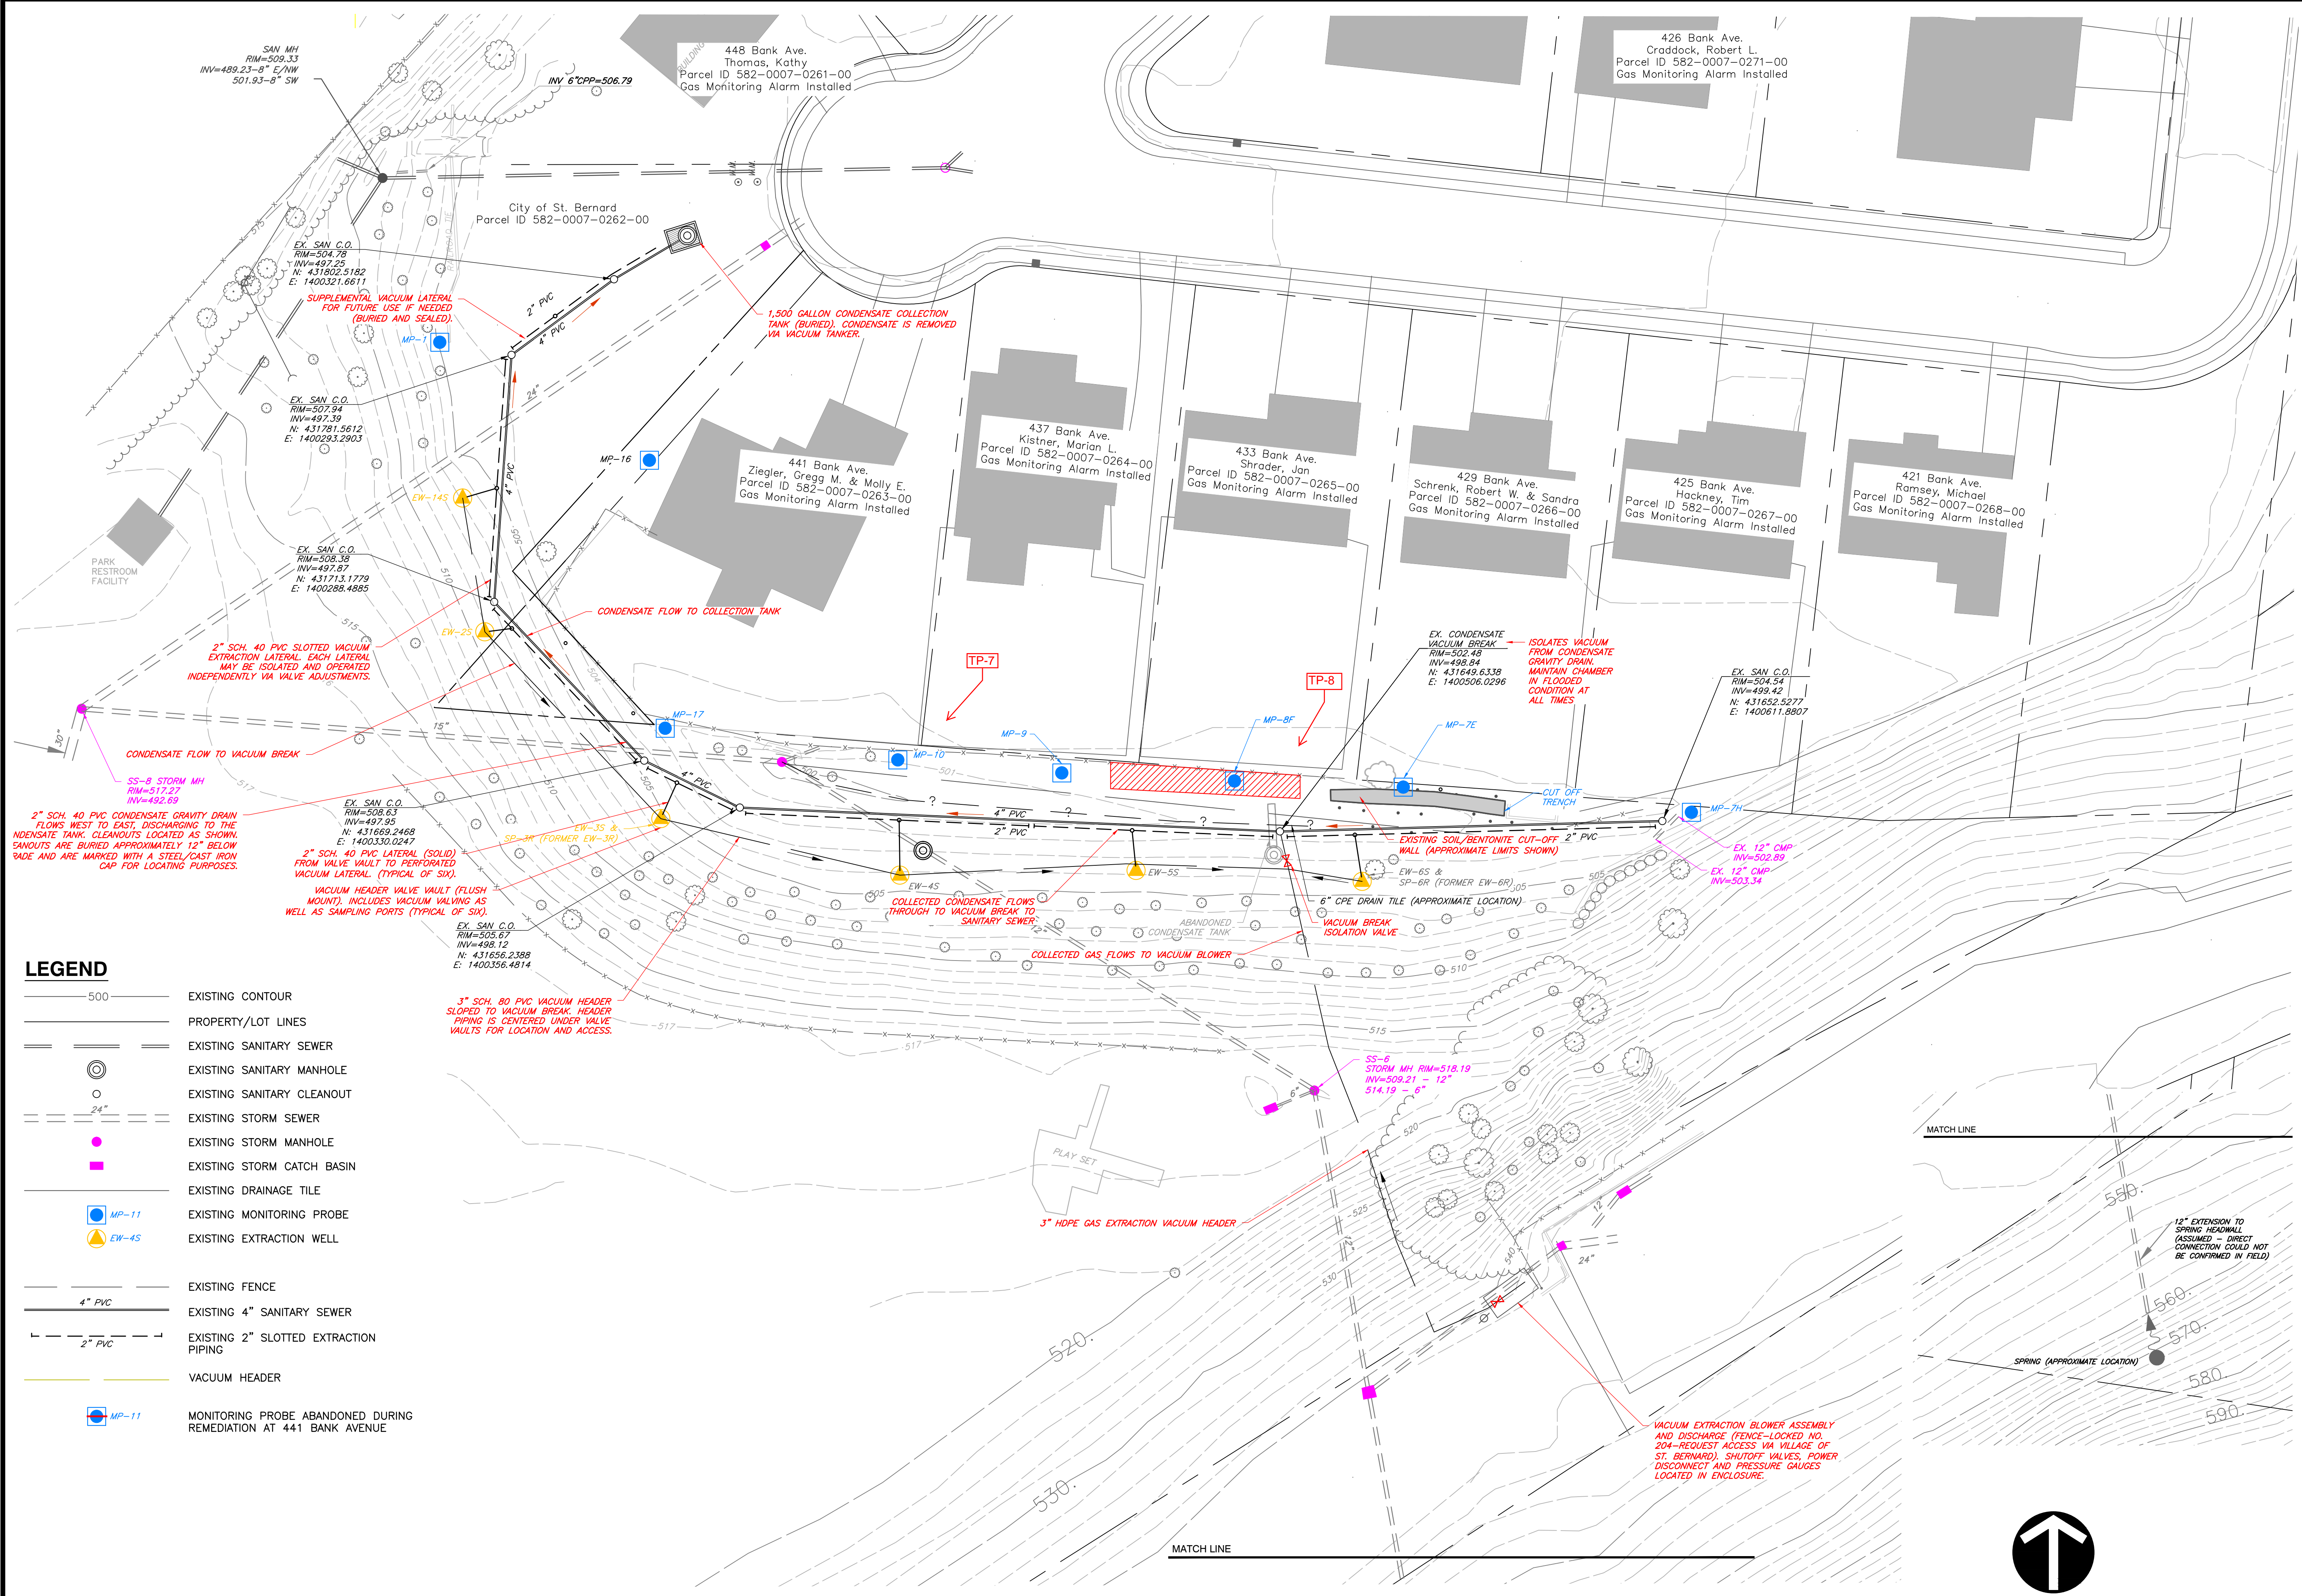
The results of the contingency monitoring performed to date are included in Attachment B. The most recent monitoring was performed on August 2, 2017. Combustible gas concentrations above the compliance threshold were detected at MP-10.

The absence of pressure at MP-10 indicates that there is no driving force that could cause gas migration over a significant distance. The methane detected at MP-10 is likely either a localized concentration or is present due to migration driven only by a concentration gradient/diffusion. Given this condition, it is unlikely that sufficient methane to present a risk to human health and safety will reach the residences. The residences adjacent to the landfill (excluding the Schrenk residence) have gas alarms and there have been no reported detections of landfill related combustible gas, indicating that these short term detections of combustible gas as has occurred at MP-10 do not represent a risk to the residences. At this time, no further remedial actions are proposed.

The collection and control system was adjusted to apply additional vacuum to the segment in the vicinity of MP-10, specifically the segment monitored by EW-4S. This was done by reducing vacuum on the other selected segments in the system.
