November 5, 2021
File No. 23212007.09

Subject: Village of St. Bernard Landfill
MP-9 Contingency Monitoring 2nd 30-day Report

This letter serves as the second 30-day report. The 30-day submittal date is November 7, 2021. Submittal of this report on November 5, 2021, (within 60 days after the last 30-day report) fulfills the requirements of the applicable rule, OAC 3745-27-12 (E)(5)(g)(ii). A site map is presented as Figure 1 in Attachment A.

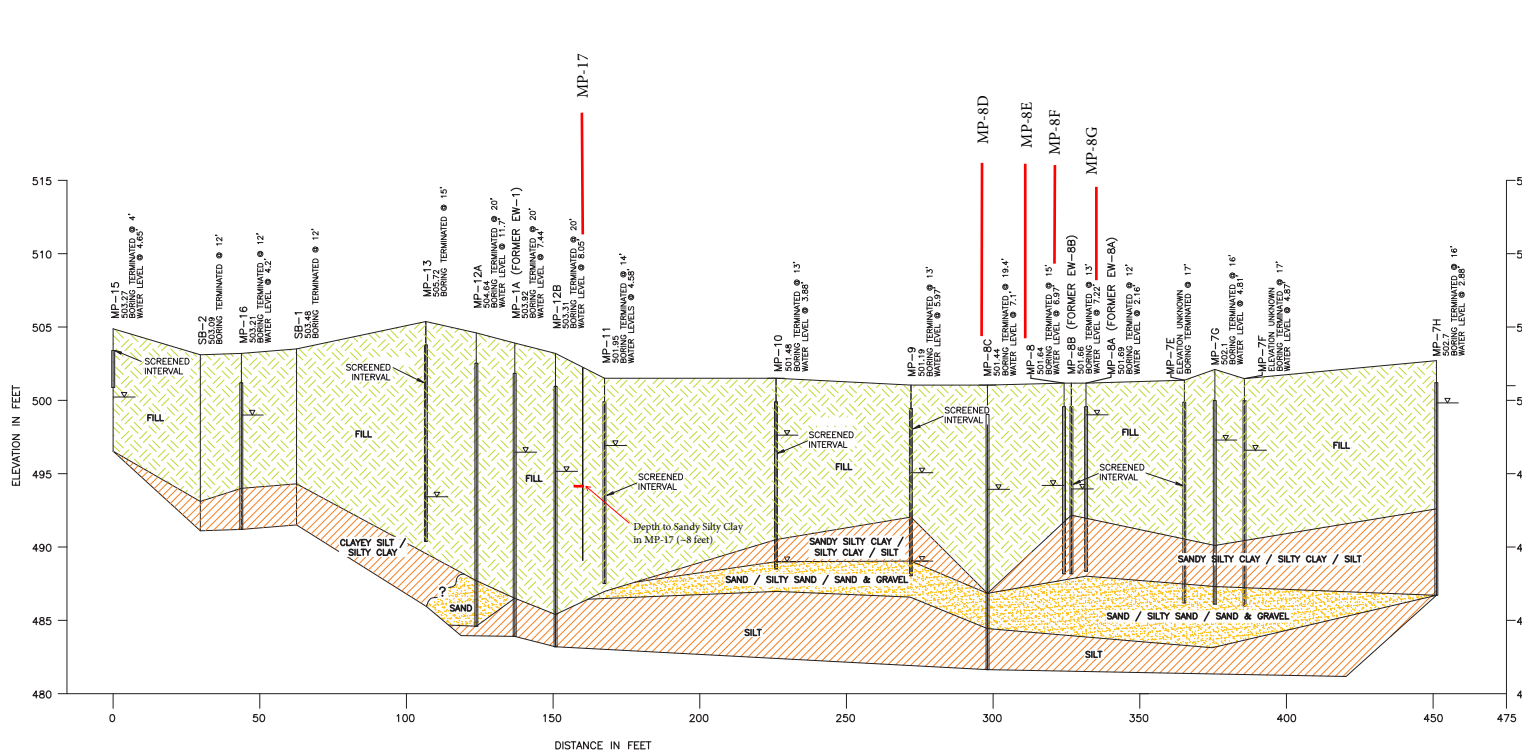
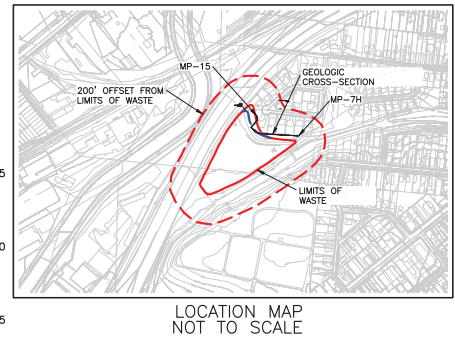
FIGURE 7. CEC 2011 Northern Geologic Cross Section

Along the northern perimeter of the site, the former landfill property is contiguous with several residential properties along Bank Avenue. Essentially, this area consists of a flat terrace, projecting out from the toe of the landfill slope and transitioning into the back yards of the Bank Avenue residences. This terrace was raised to its current elevation by the placement of two generations of fill. A cross section along this northern perimeter is presented as Figure 2 in Attachment A. The boring logs used to prepare the cross section are presented in the EGMP. The log for MP-9 is included in this report in Attachment C. The fill soils, in particular the lower fill, contain hard fill and miscellaneous debris. As a result, the near surface geologic profile of this terrace is varied. The fill soil matrix in the vicinity of MP-9 is a sandy silt or sandy clay. The presence of the hard fill and debris likely increases the porosity and results in a porosity that approaches that typically assumed for granular soils, i.e. 25 percent. Recent water level measurements show that the fill soil in the vicinity of MP-9 is saturated at approximately 7 feet below the ground surface. MP-9 is screened from approximately 2 to 12 feet below the ground surface.

As part of the delineation investigation conducted in 2013, a test pit, TP-7, was excavated in the vicinity of MP-9. The log for TP-7 is included in Attachment C. The unsaturated portion of the fill layer is the primary pathway. Geotechnical testing of this material as part of the delineation investigation showed that it can be classified as silty sand with gravel. Porosity of the soil matrix of the fill is considered to be moderate. The presence of large pieces of concrete debris within the fill results in the potential for isolated, unconnected open void space, depending on the location and orientation of the concrete debris.
