## SCS ENGINEERS

November 21, 2017  
File No. 23212007.05

Subject: Village of St. Bernard Landfill  
MP-10 Final Contingency Monitoring Report

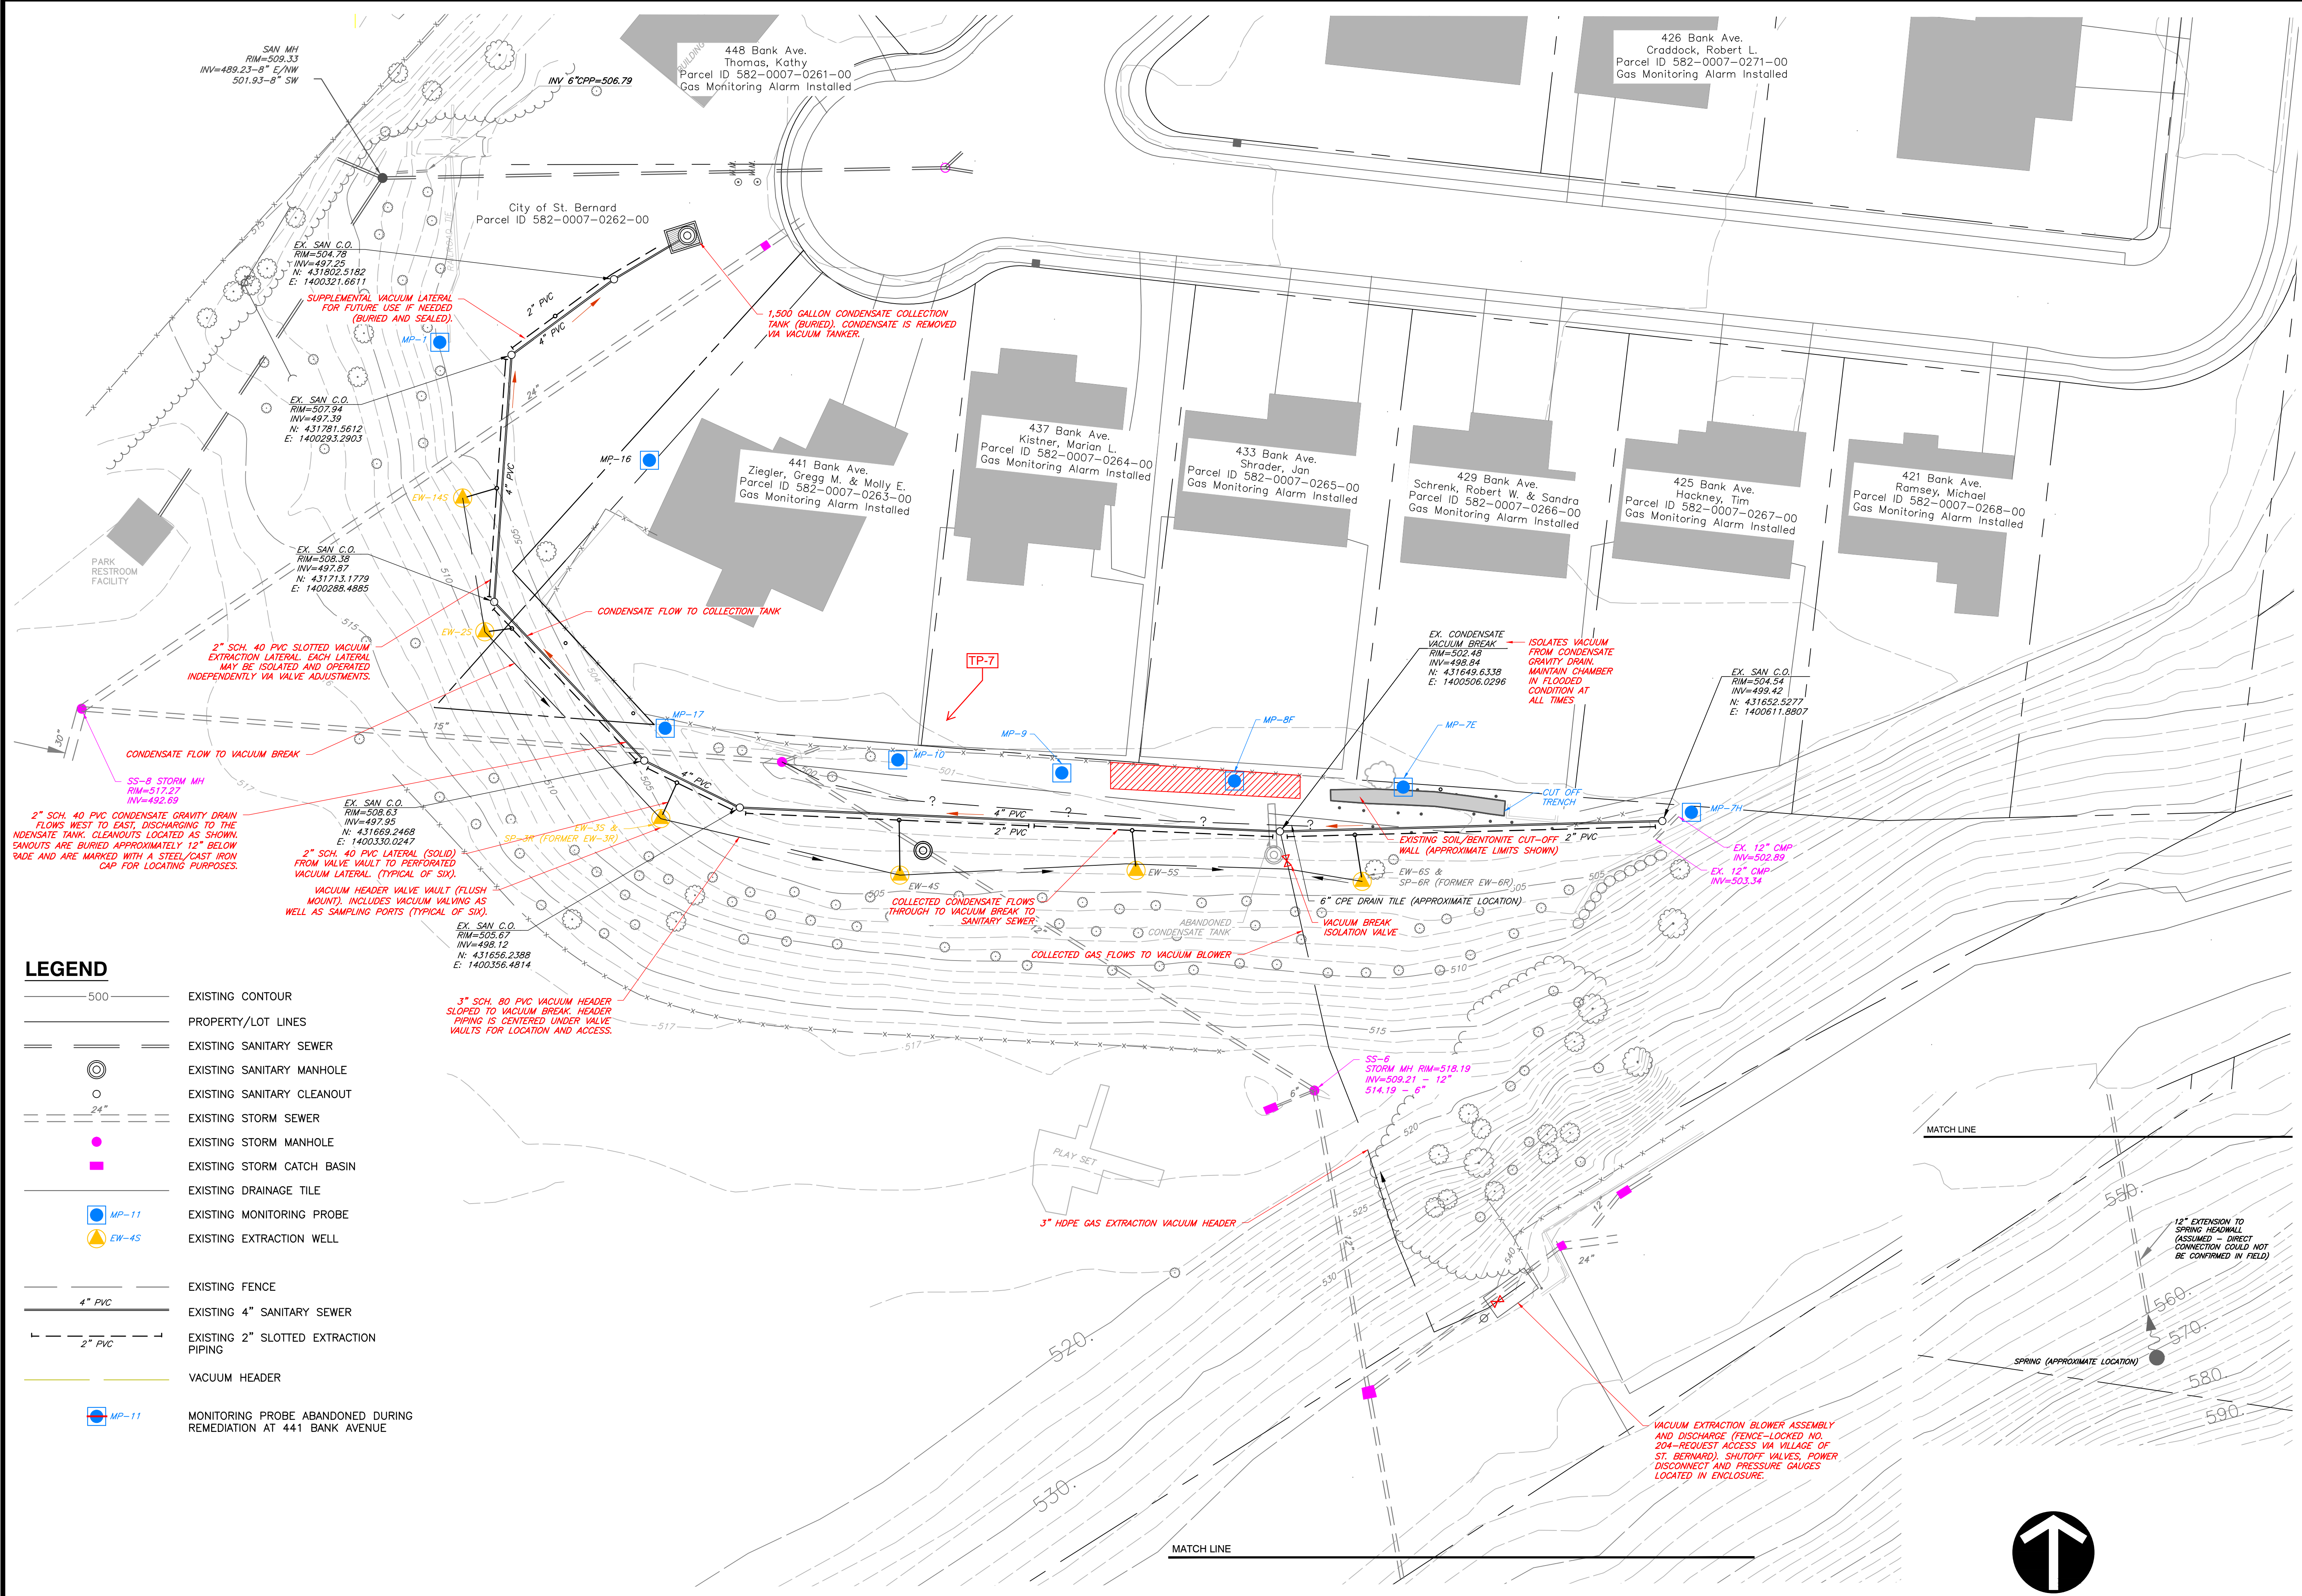
The results of the contingency monitoring performed to date are included in Attachment B. The most recent monitoring was performed on November 17, 2017. The lateral extent of the explosive gas concentration above the threshold limit was the immediate vicinity of MP-10. No concentrations of explosive gas were detected in MP-17, located approximately 75 feet west of MP-10, or in MP-9, which is located 55 feet east of MP-10. No explosive gas was detected at the BP-1 bar punch location, located at the southwest corner of the Kistner property, 437 Bank Avenue approximately 10 feet north northeast of MP-10.
