Subject: Village of St. Bernard Landfill
Certification Report for Probe Abandonment

**CERTIFICATION REPORT
EXPLOSIVE GAS MONITORING PROBE
ABANDONMENT
ST. BERNARD LANDFILL**

July 24, 2015
Revised August 10, 2015
File No. 23212007.03

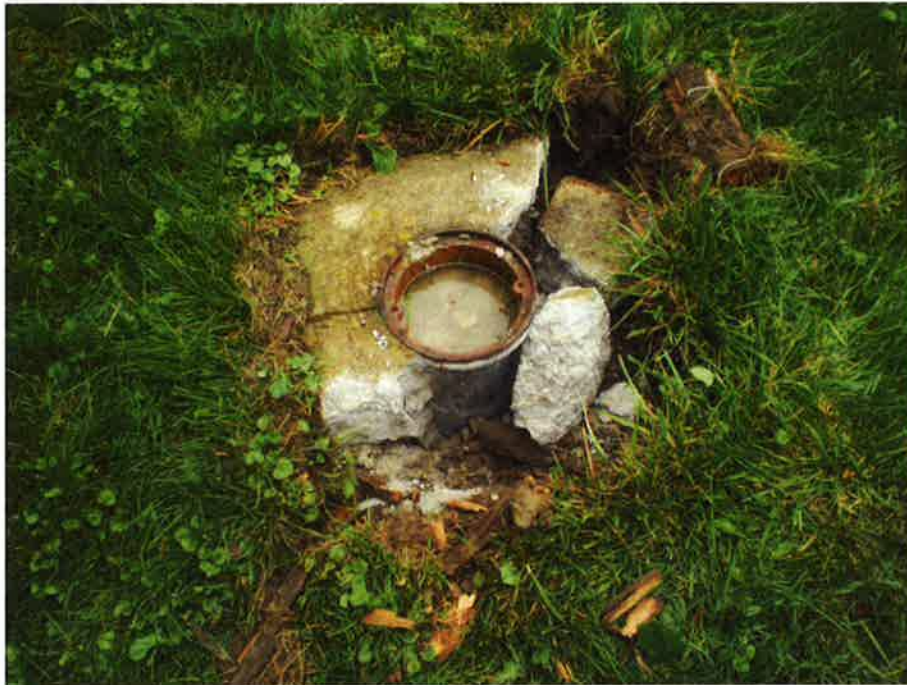
Photo 1. MP-15 with concrete pad partially removed.

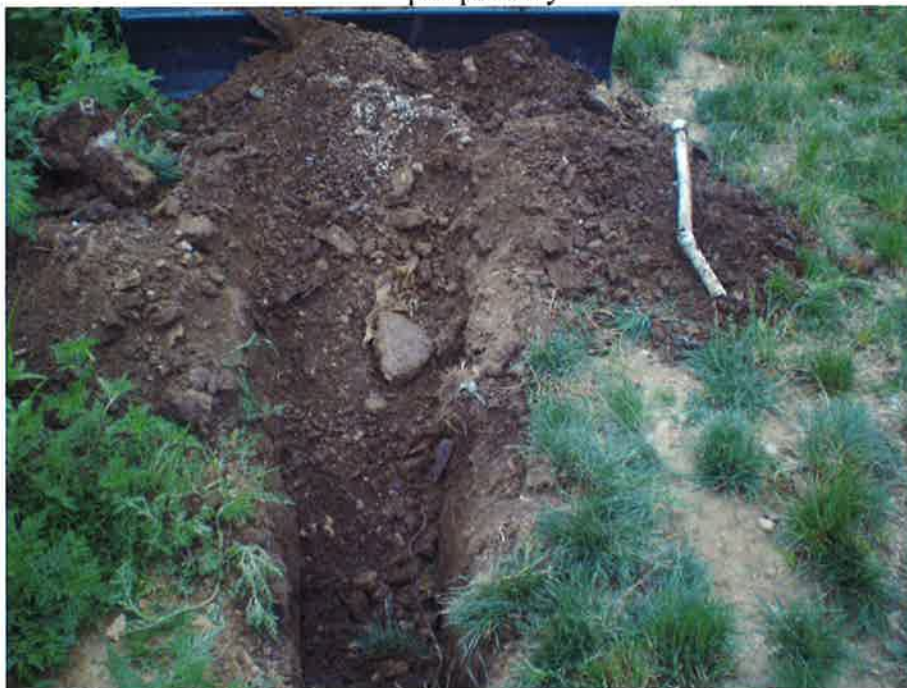
MP-15 – During excavation, the entire casing pulled out. The annulus was filled with bentonite chips and hydrated.

Photo 2. MP-15 removed during excavation.

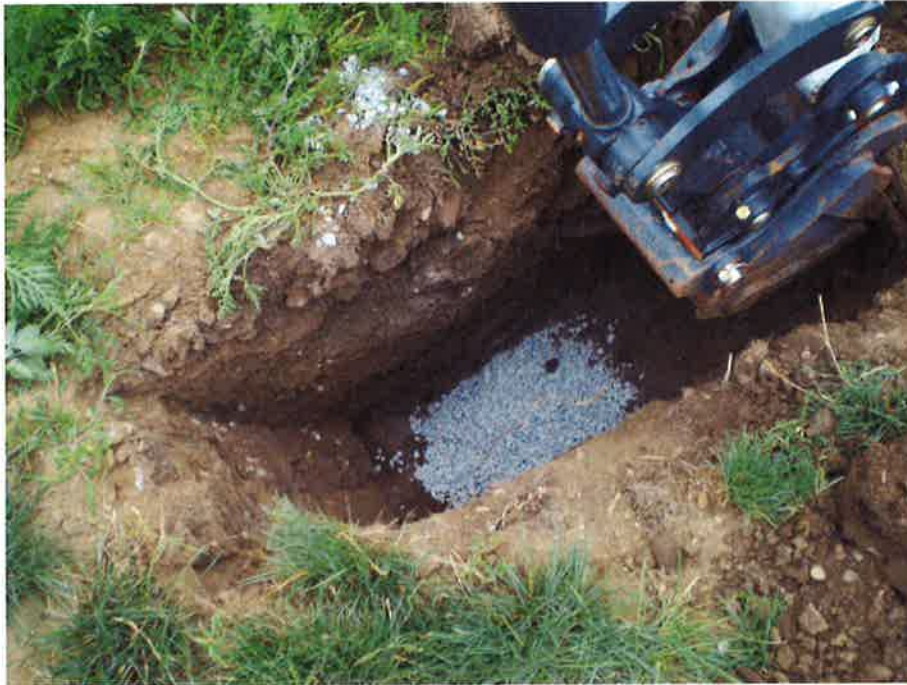
Photo 3. Bentonite chips placed in MP-15 excavation.

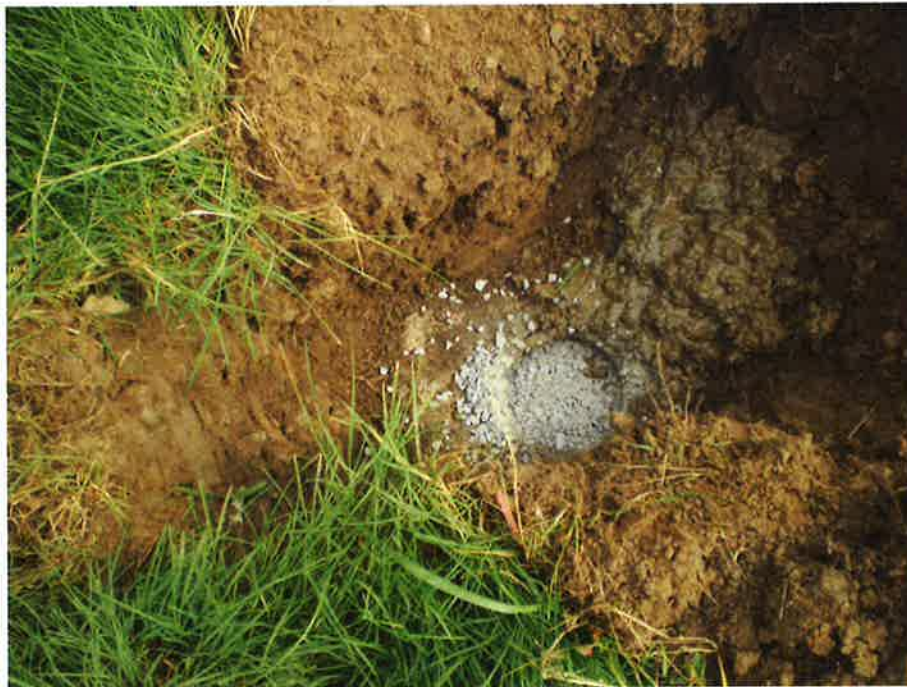
SP-14 – After removal of the concrete surface pad and excavation to a depth of approximately 2.5 feet, a second concrete pad was encountered. The surface in this vicinity had been regraded and SP-14 had been extended. Removal of this second concrete surface pad would have resulted in a large excavation. The second concrete pad will protect the remaining probe casing. A cap placed on the probe casing within the lower concrete pad. It was inadvertently not glued, but was forced on. The opening of the second concrete pad was filled with bentonite before backfilling. Because the surface seal was not compromised, the 1-foot of bentonite above the capped casing was not required.

Photo 4. Bentonite chips placed in buried flush mount protective casing at SP-14.

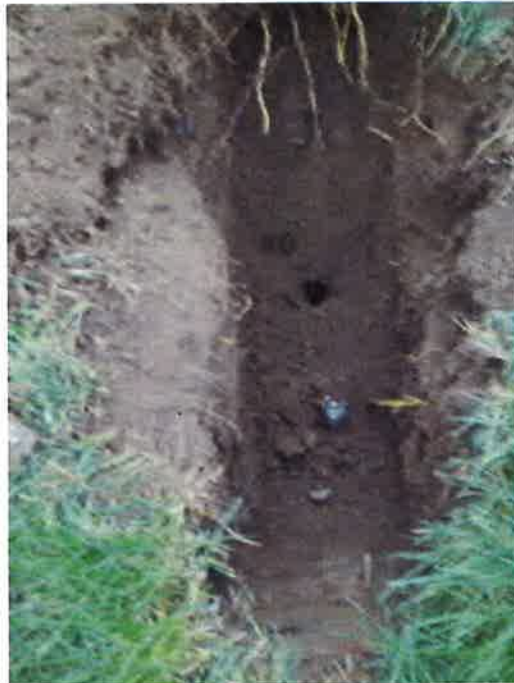
SP-2 and SP-2R – Part of one of the casings pulled up during excavation. The annulus was filled with bentonite chips. The other casing was capped. It was inadvertently not glued, but was forced on and then covered with bentonite chips and hydrated.

Photo 5. Excavation for SP-2 and SP-2R. One casing has been partially pulled up during excavation.

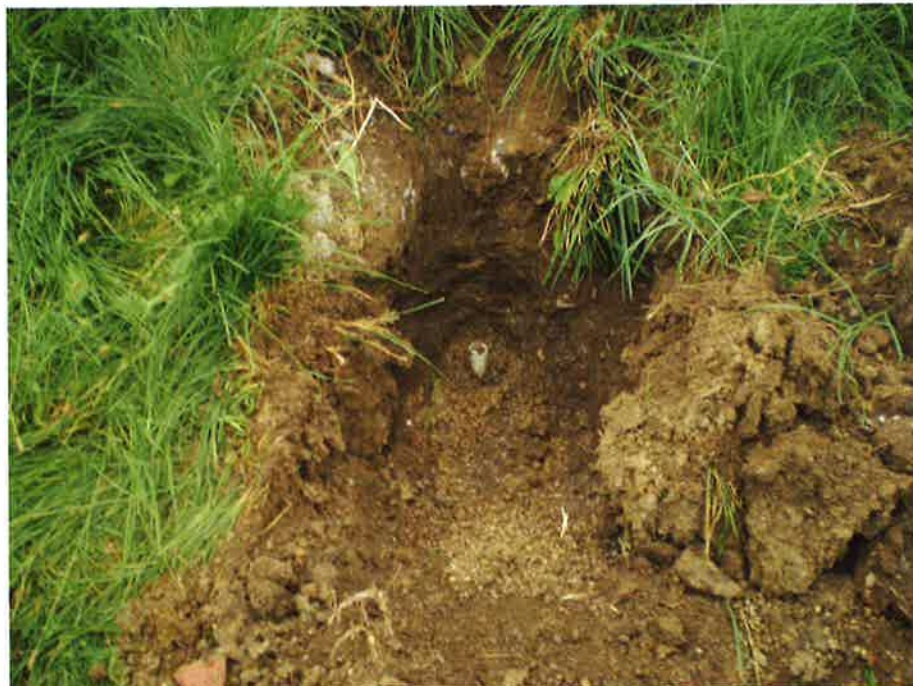
SP-12 – During excavation, large pieces of concrete were encountered at each end of the excavation. The pieces were large enough that it was not practical to remove them with the small excavator. The excavation could not be extended below approximately 2.5 feet. Additional topsoil was mounded above this location after backfilling to attempt to provide the 3 foot isolation distance.

Photo 6. SP-12 excavation.

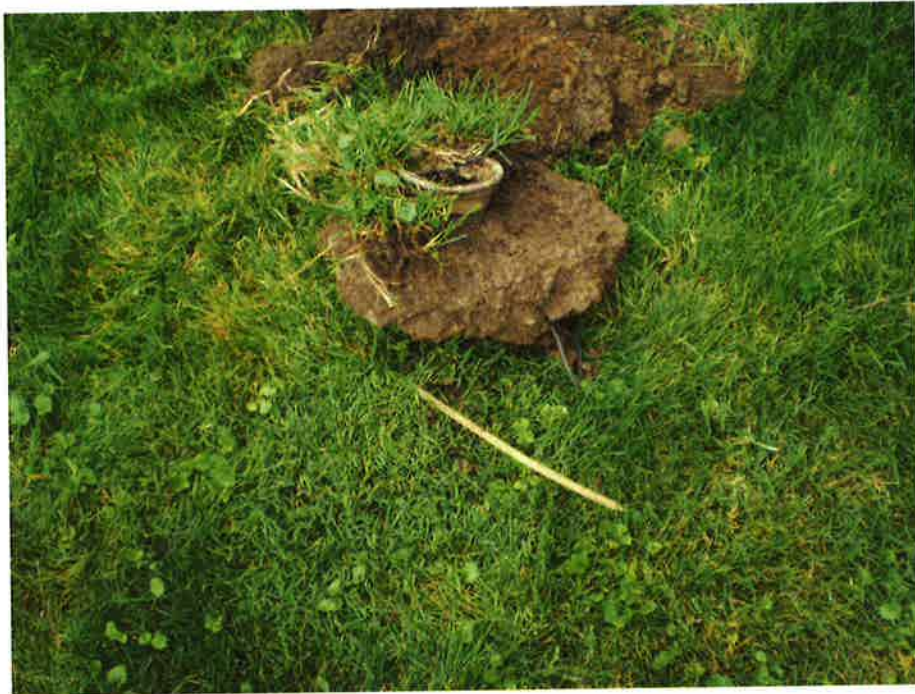
MP-7T – Upon excavation, this probe was found to be constructed with perforated 3/8-inch tubing.

Photo 7. MP-7T(?) flush mount protective casing and tubing that had been installed in this probe location.

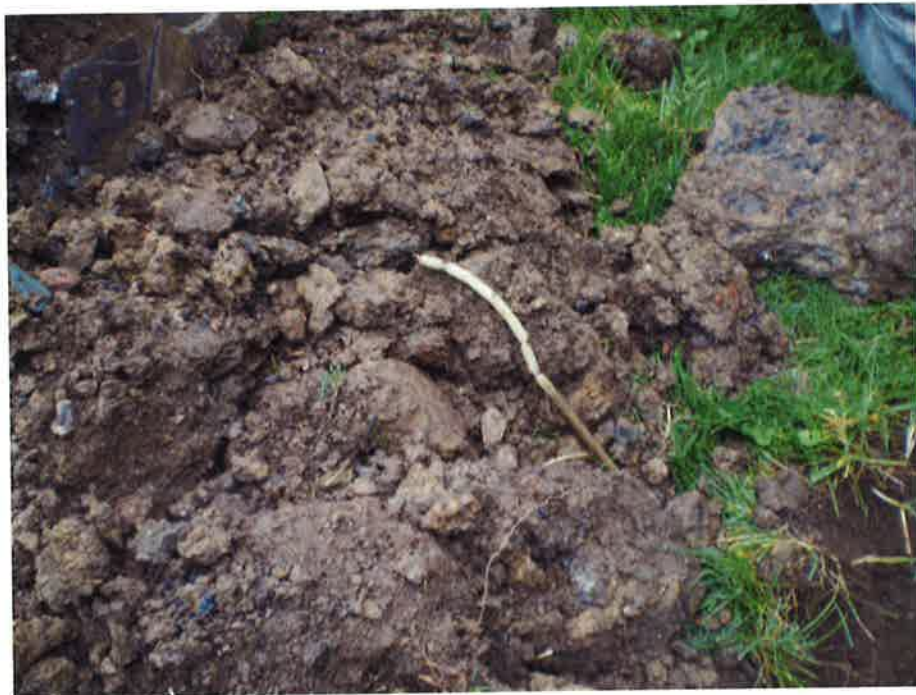
Photo 8. Perforations in tubing from MP-7T(?).

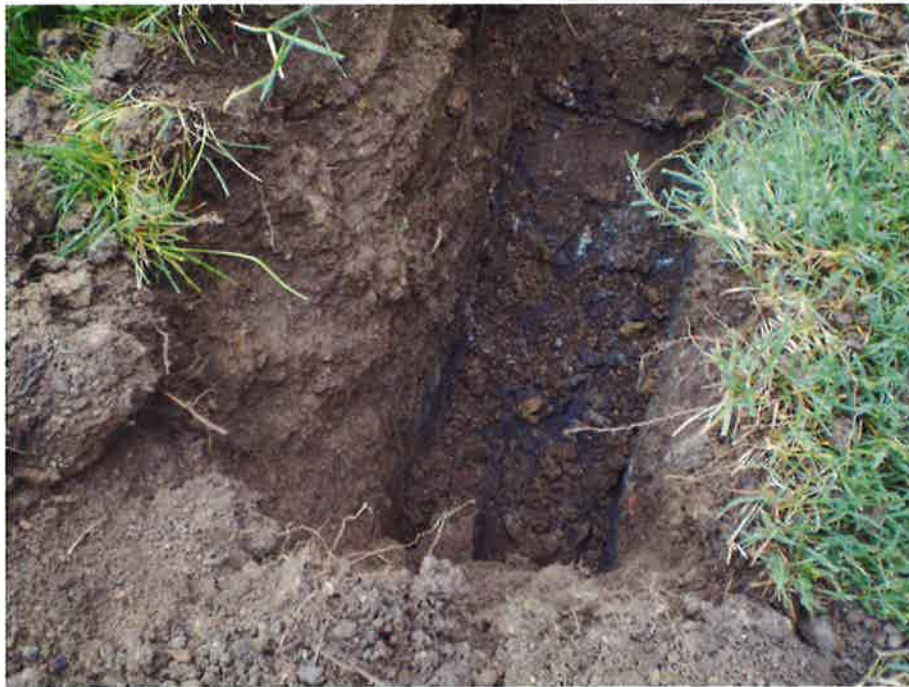
Photo 9. Bottom of excavation at MP-7T(?).

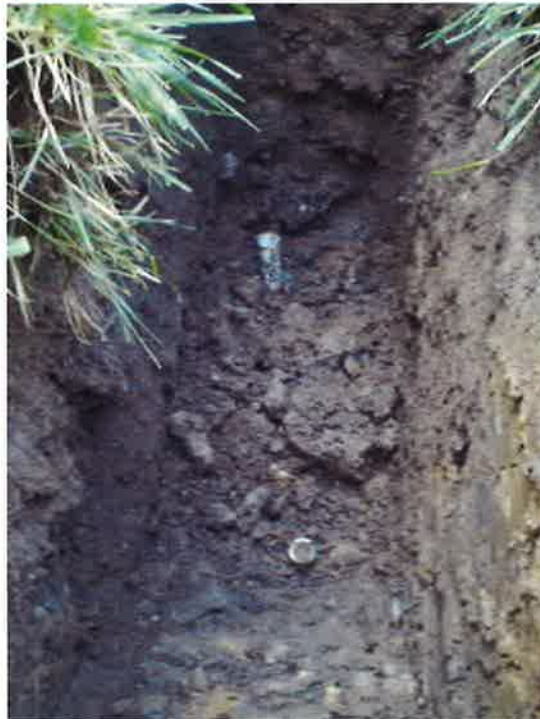
MP-7F – Upon excavation of MP-7F, a second 1-inch PVC casing was exposed. This second casing was filled with bentonite chips before completing the remaining abandonment steps.

Photo 10. MP-7F in foreground with unknown probe encountered in the excavation of MP-7F in the background.

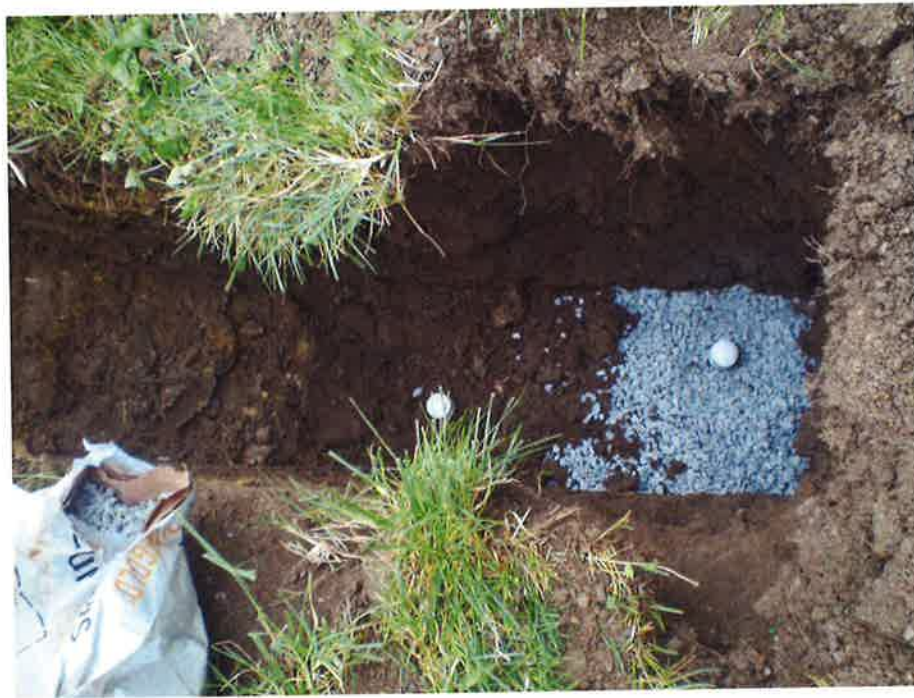
Photo 11. MP-7F and unknown probe have been capped and bentonite chip placement has started.

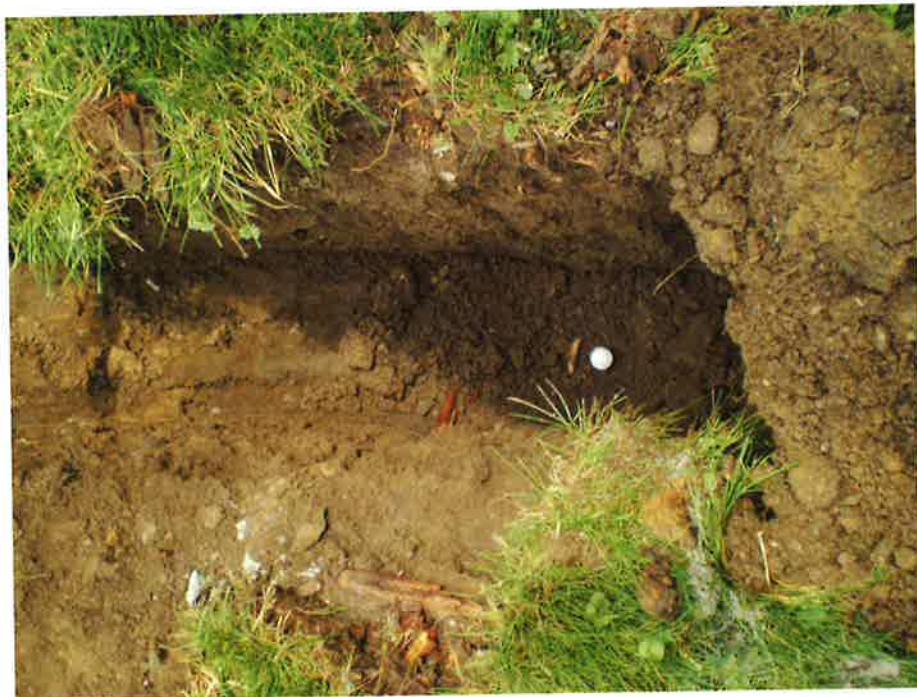
MP-7G – during the removal of the concrete pad, it was noted that MP-7G had a “T” with a horizontal 1-inch PVC pipe connected to the riser. When the pad was completely excavated, the horizontal pipe was also excavated and it was noted that the horizontal pipe had been capped off approximately 2 feet away from the probe.

Photo 12. MP-7G excavated and capped.

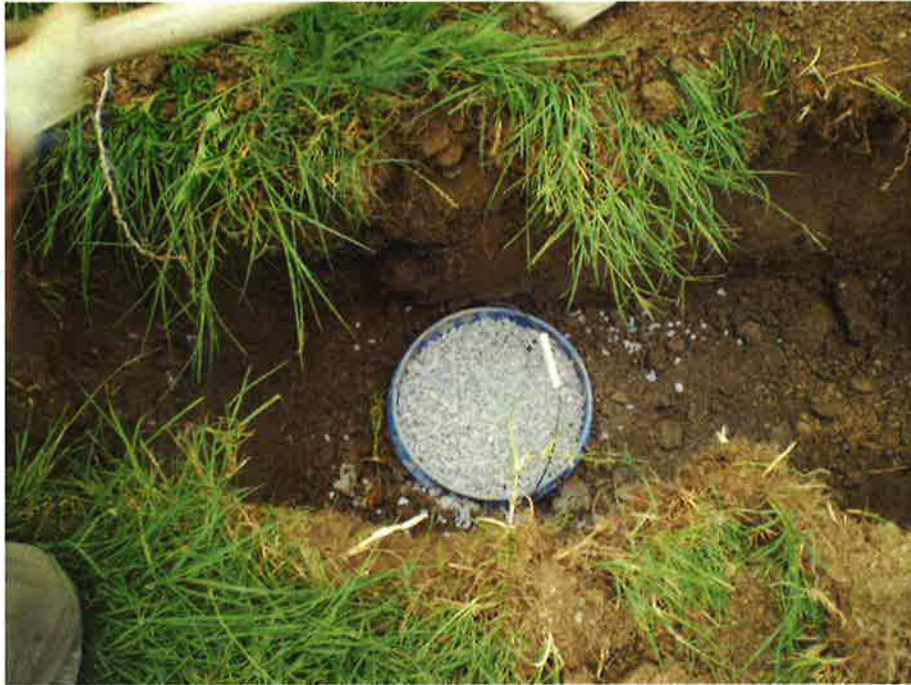
Photo 13. Placement of bentonite chips above MP-7G using a cut-off bucket as a form.

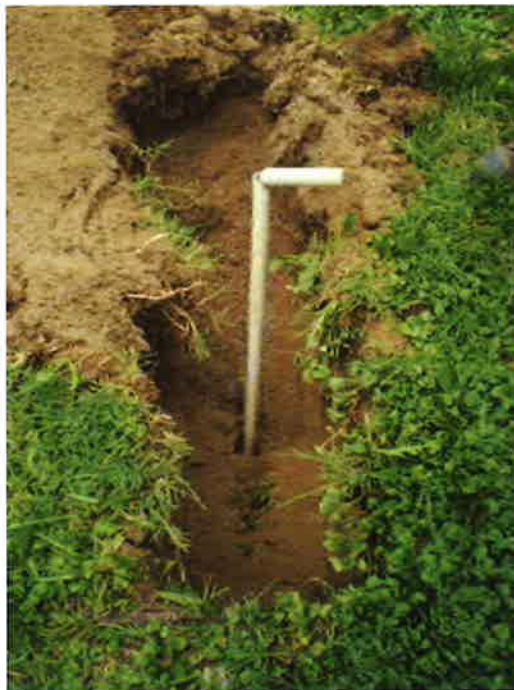
MP-8G – During the excavation, all of the probe casing pulled out of the ground. The remaining annulus was filled with bentonite chips.

Photo 14. MP-8G casing pulled out of excavation.

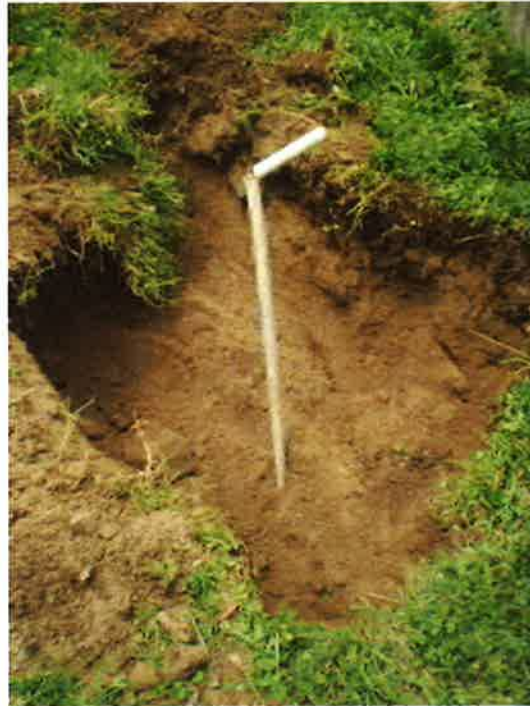
Photo 15. MP-8G casing pulled out of excavation.

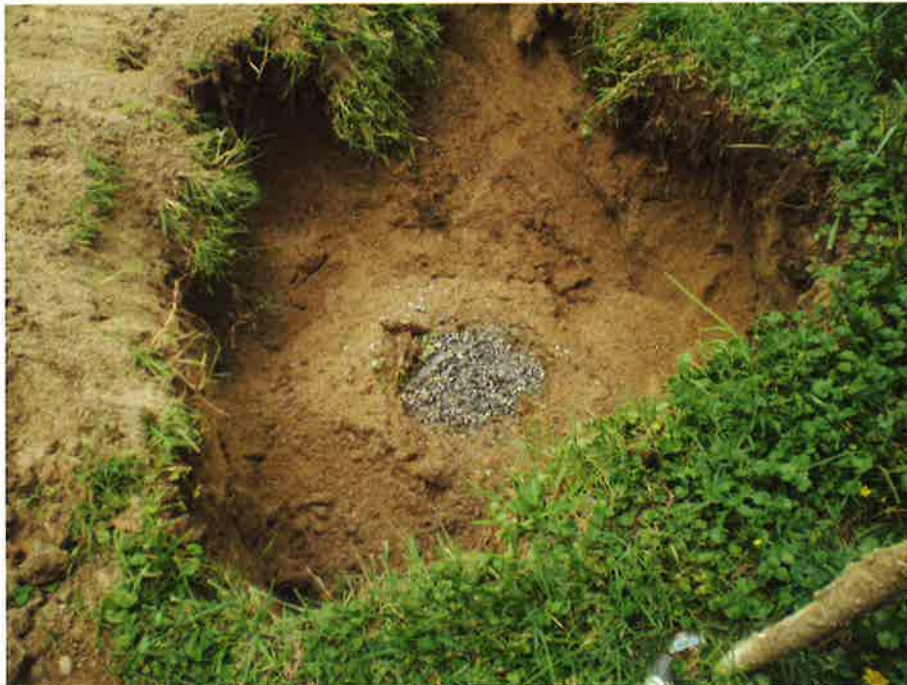
Photo 16. Bentonite chips placed above MP-8G and hydrated.

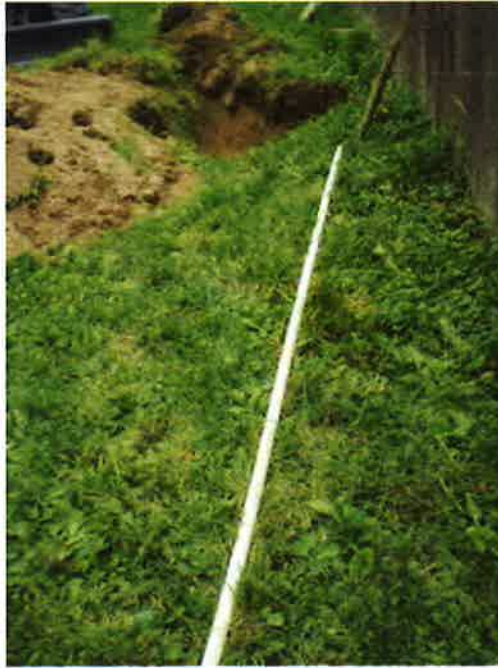
Photo 17. Probe casing pulled from MP-8G location.

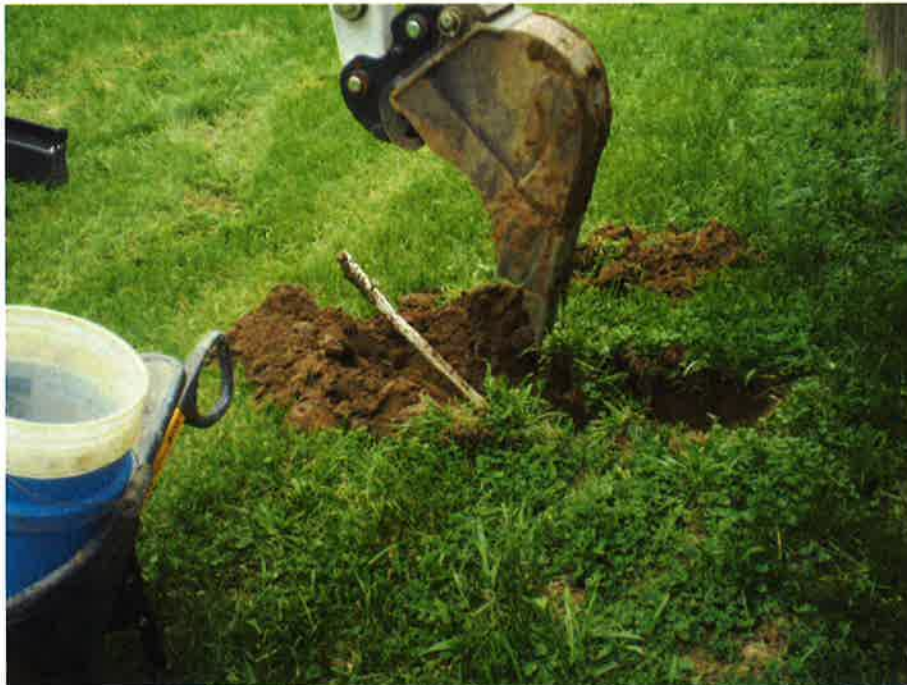
Photo 18. Casing pulled during excavation of MP-8E.

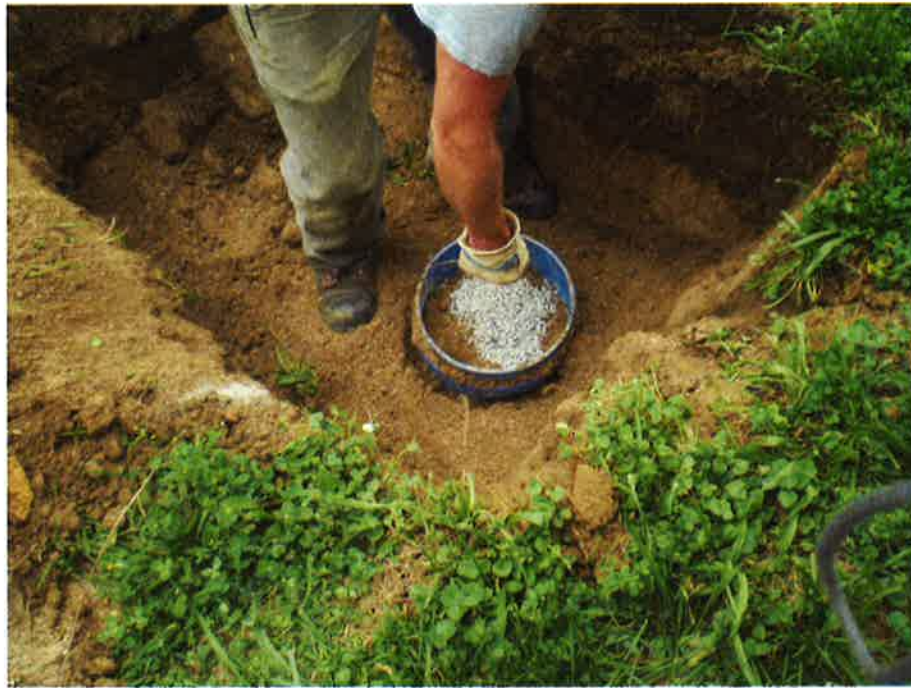
Photo 19. Removal of bucket form after backfilling around bucket, prior to hydration of bentonite chips at MP-8E location.

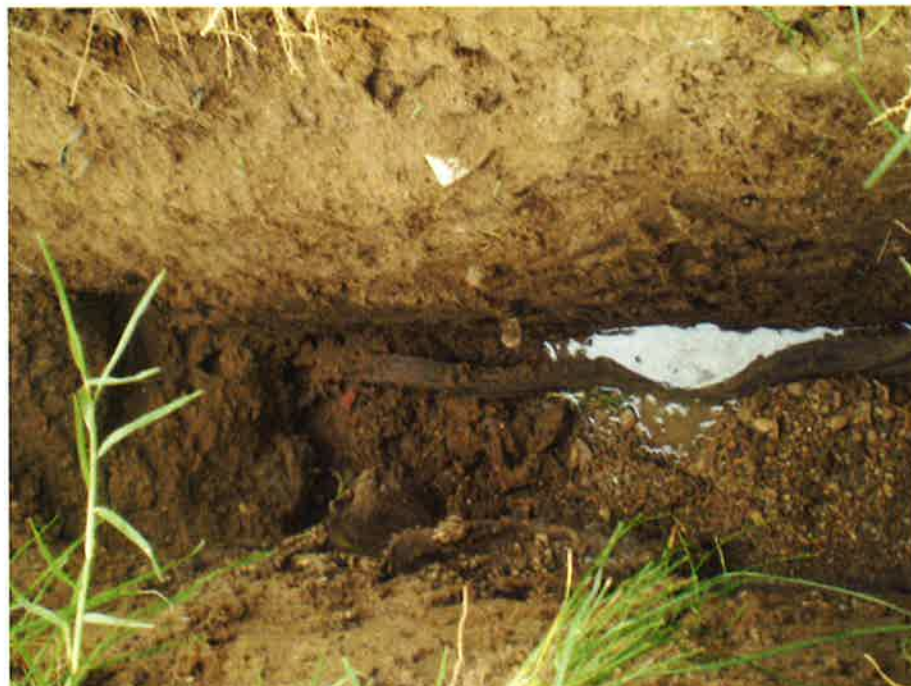
Photo 20. MP-8AR against side of excavation.

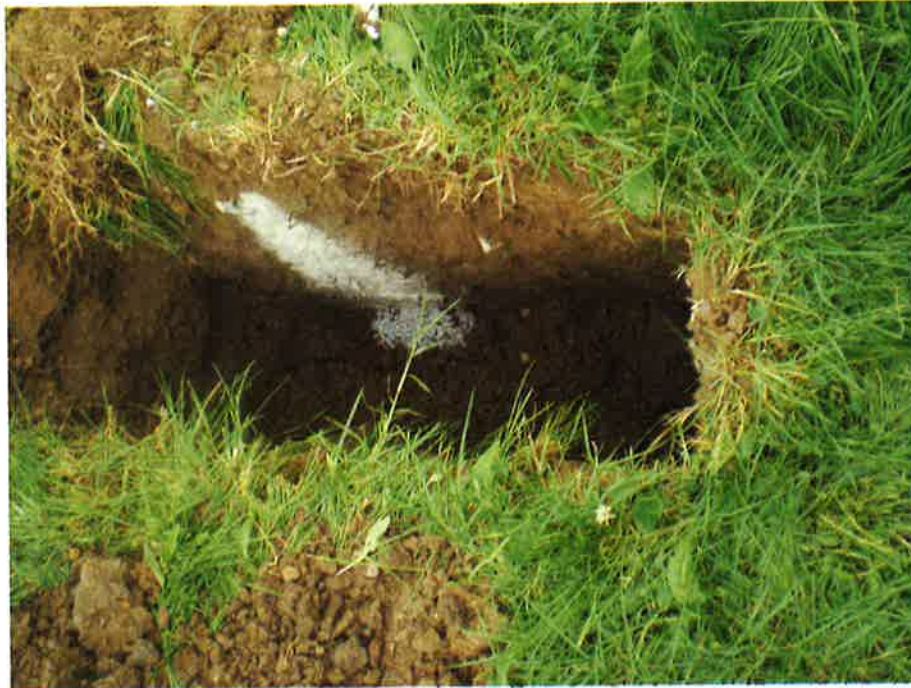
Photo 21. Placement of bentonite chips above MP-8AR using soil to contain chips.

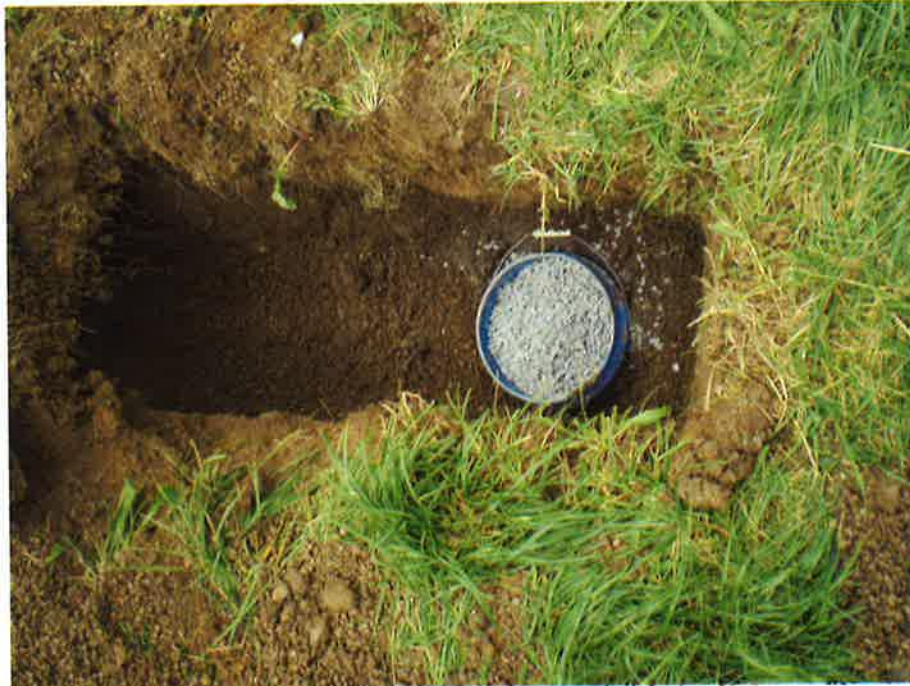
Photo 22. Bentonite placed in MP-8BR.

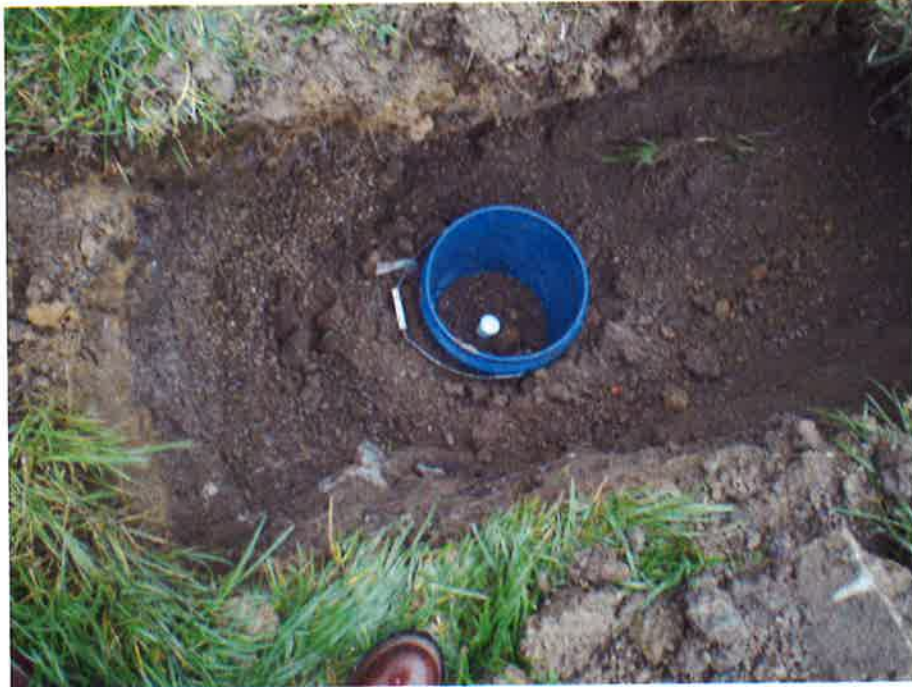
Photo 23. Bucket form placed above capped MP-8R and partially backfilled, prior to placement of bentonite chips.

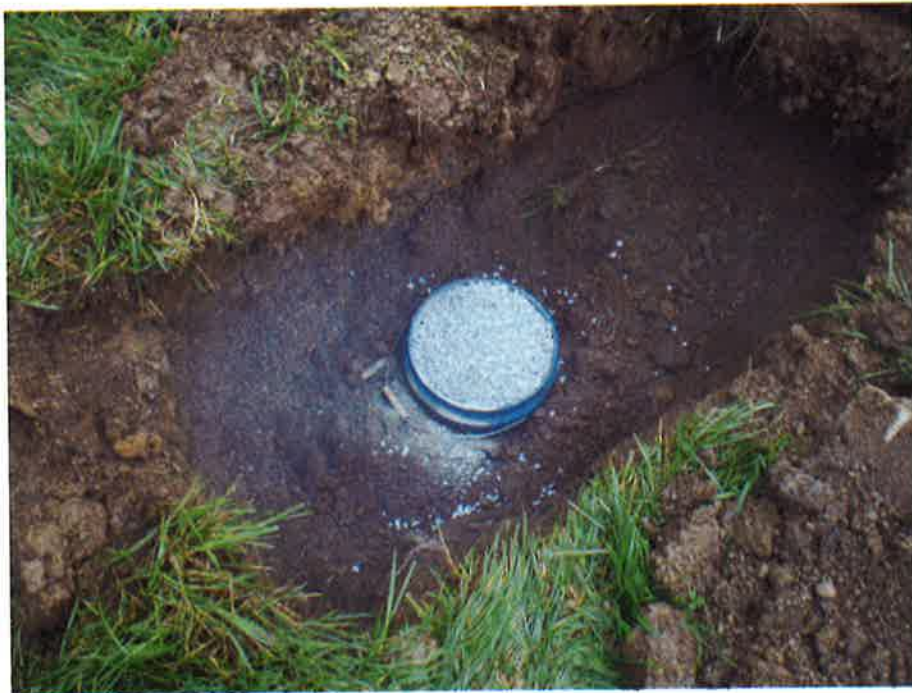
Photo 24. Bucket form filled with bentonite chips above MP-8R.

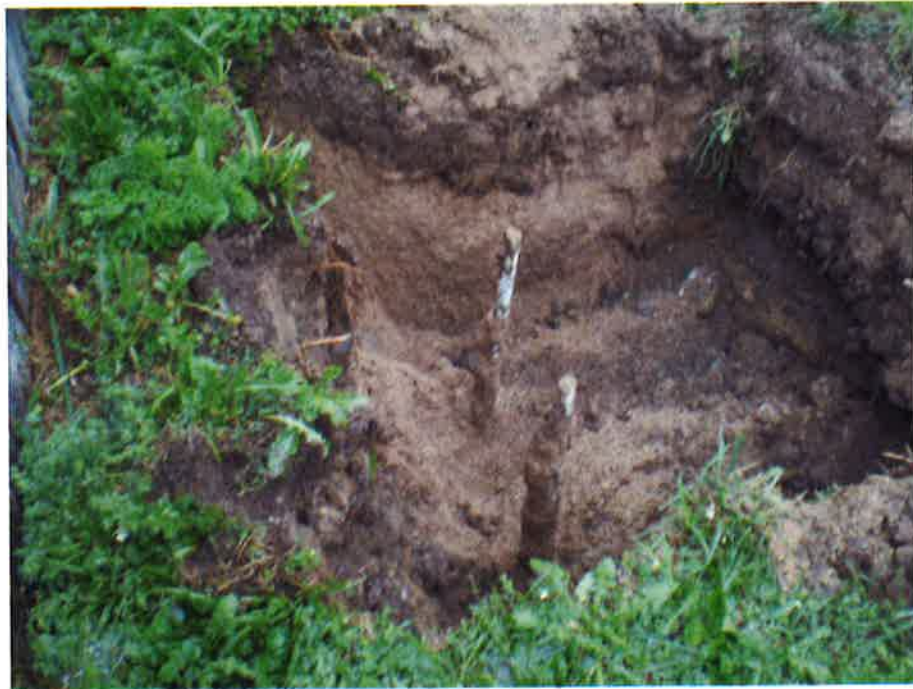
Photo 25. Excavation of MP-8D and PPA.

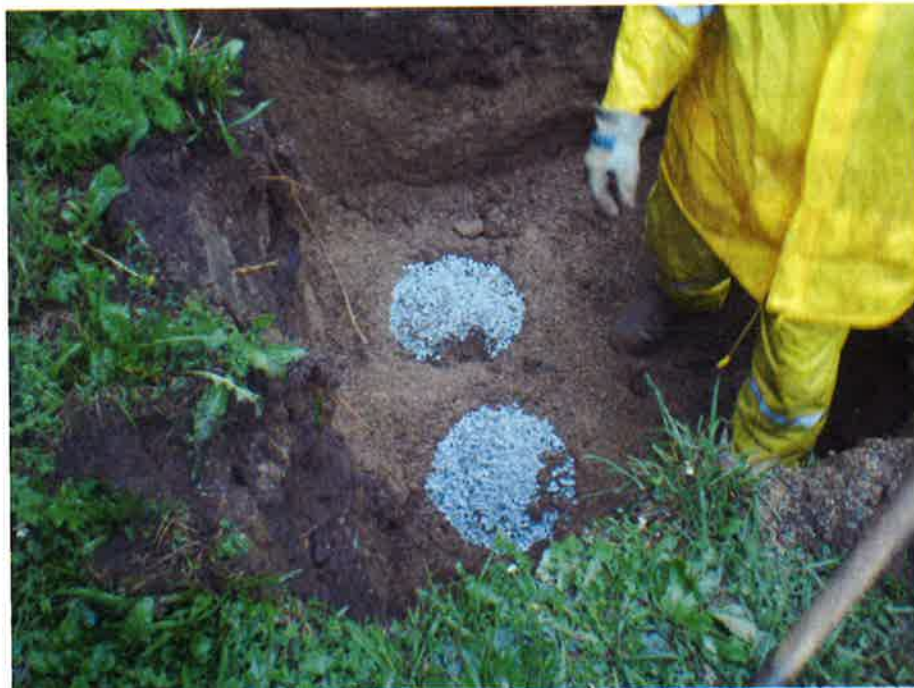
Photo 26. Bentonite chips placed above MP-8D and PPA.

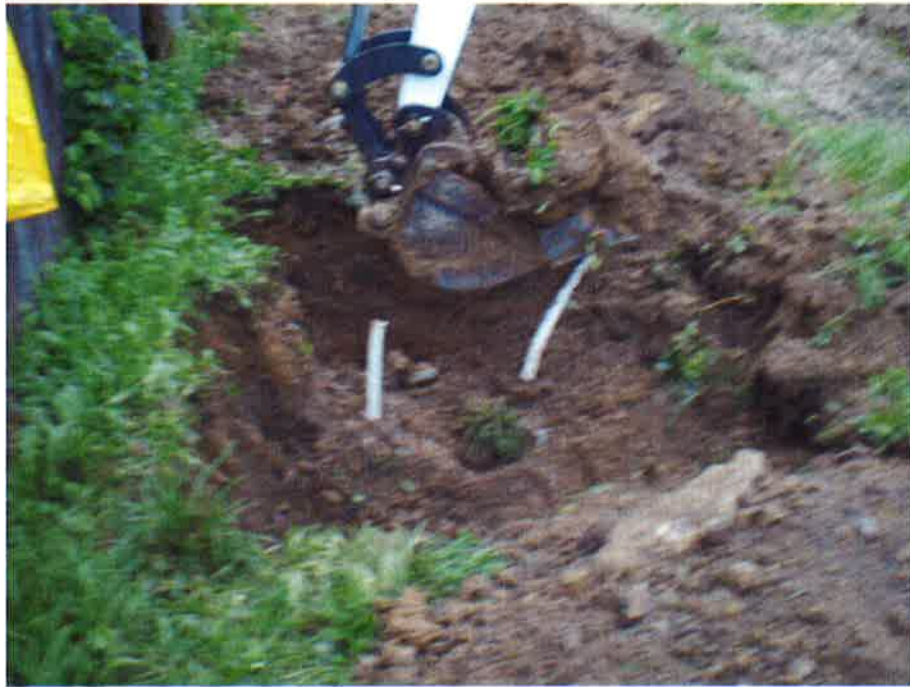
Photo 27. Excavation of DPC and FPC.

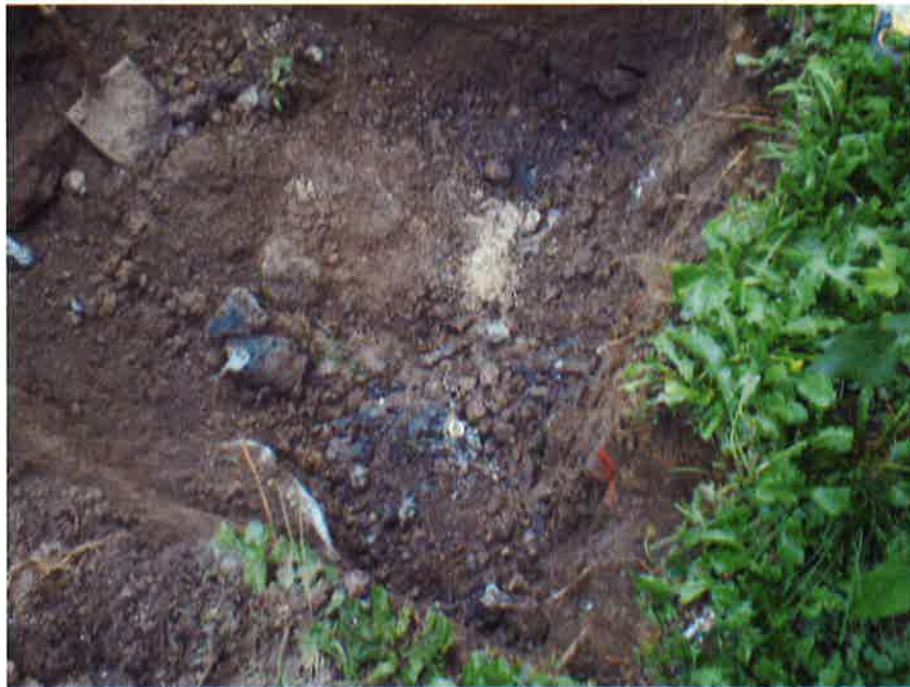
Photo 28. DPC and FPC excavated and cut off.

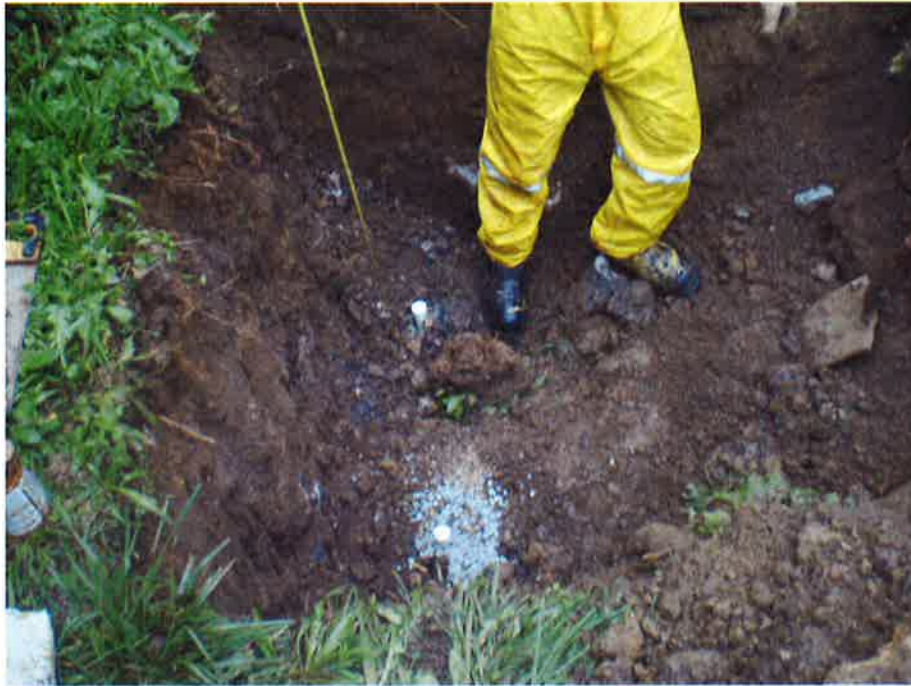
Photo 29. Checking depth of excavation at DPC.

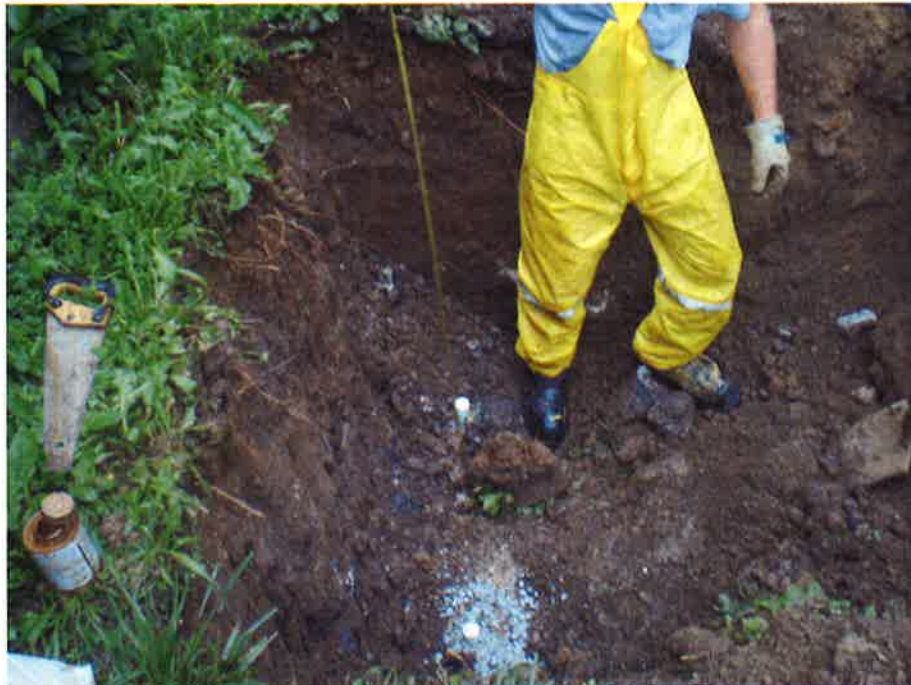
Photo 30. Checking depth of excavation at FPC.

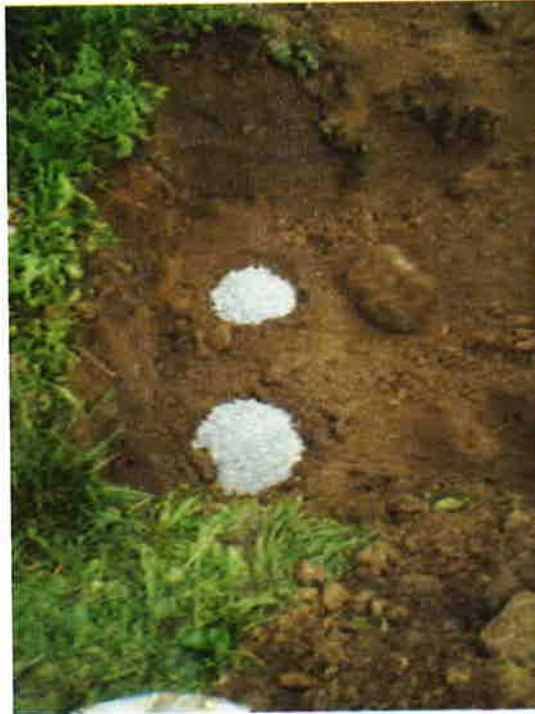
Photo 31. Bentonite chips placed above DPC and FPC.

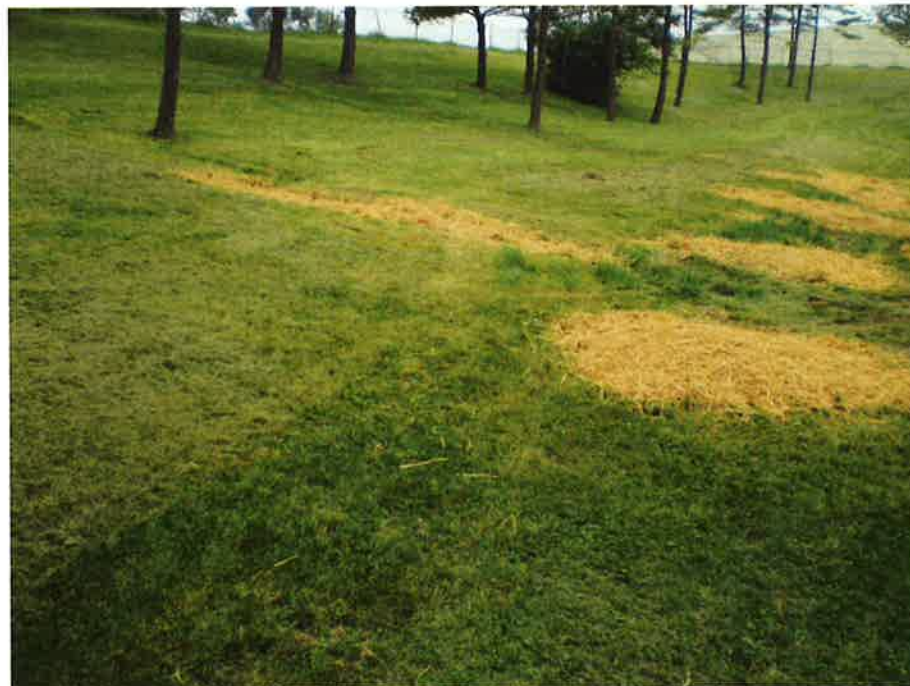
Photo 48. Some soil was added to the settled area in the vicinity of the vacuum break.
