SCS ENGINEERS

October 4, 2017
File No. 23212007.05

Subject: Village of St. Bernard Landfill
MP-10 4th Contingency Monitoring 30-day Report
MP-7E 1st & Final Contingency Monitoring 30-day Report

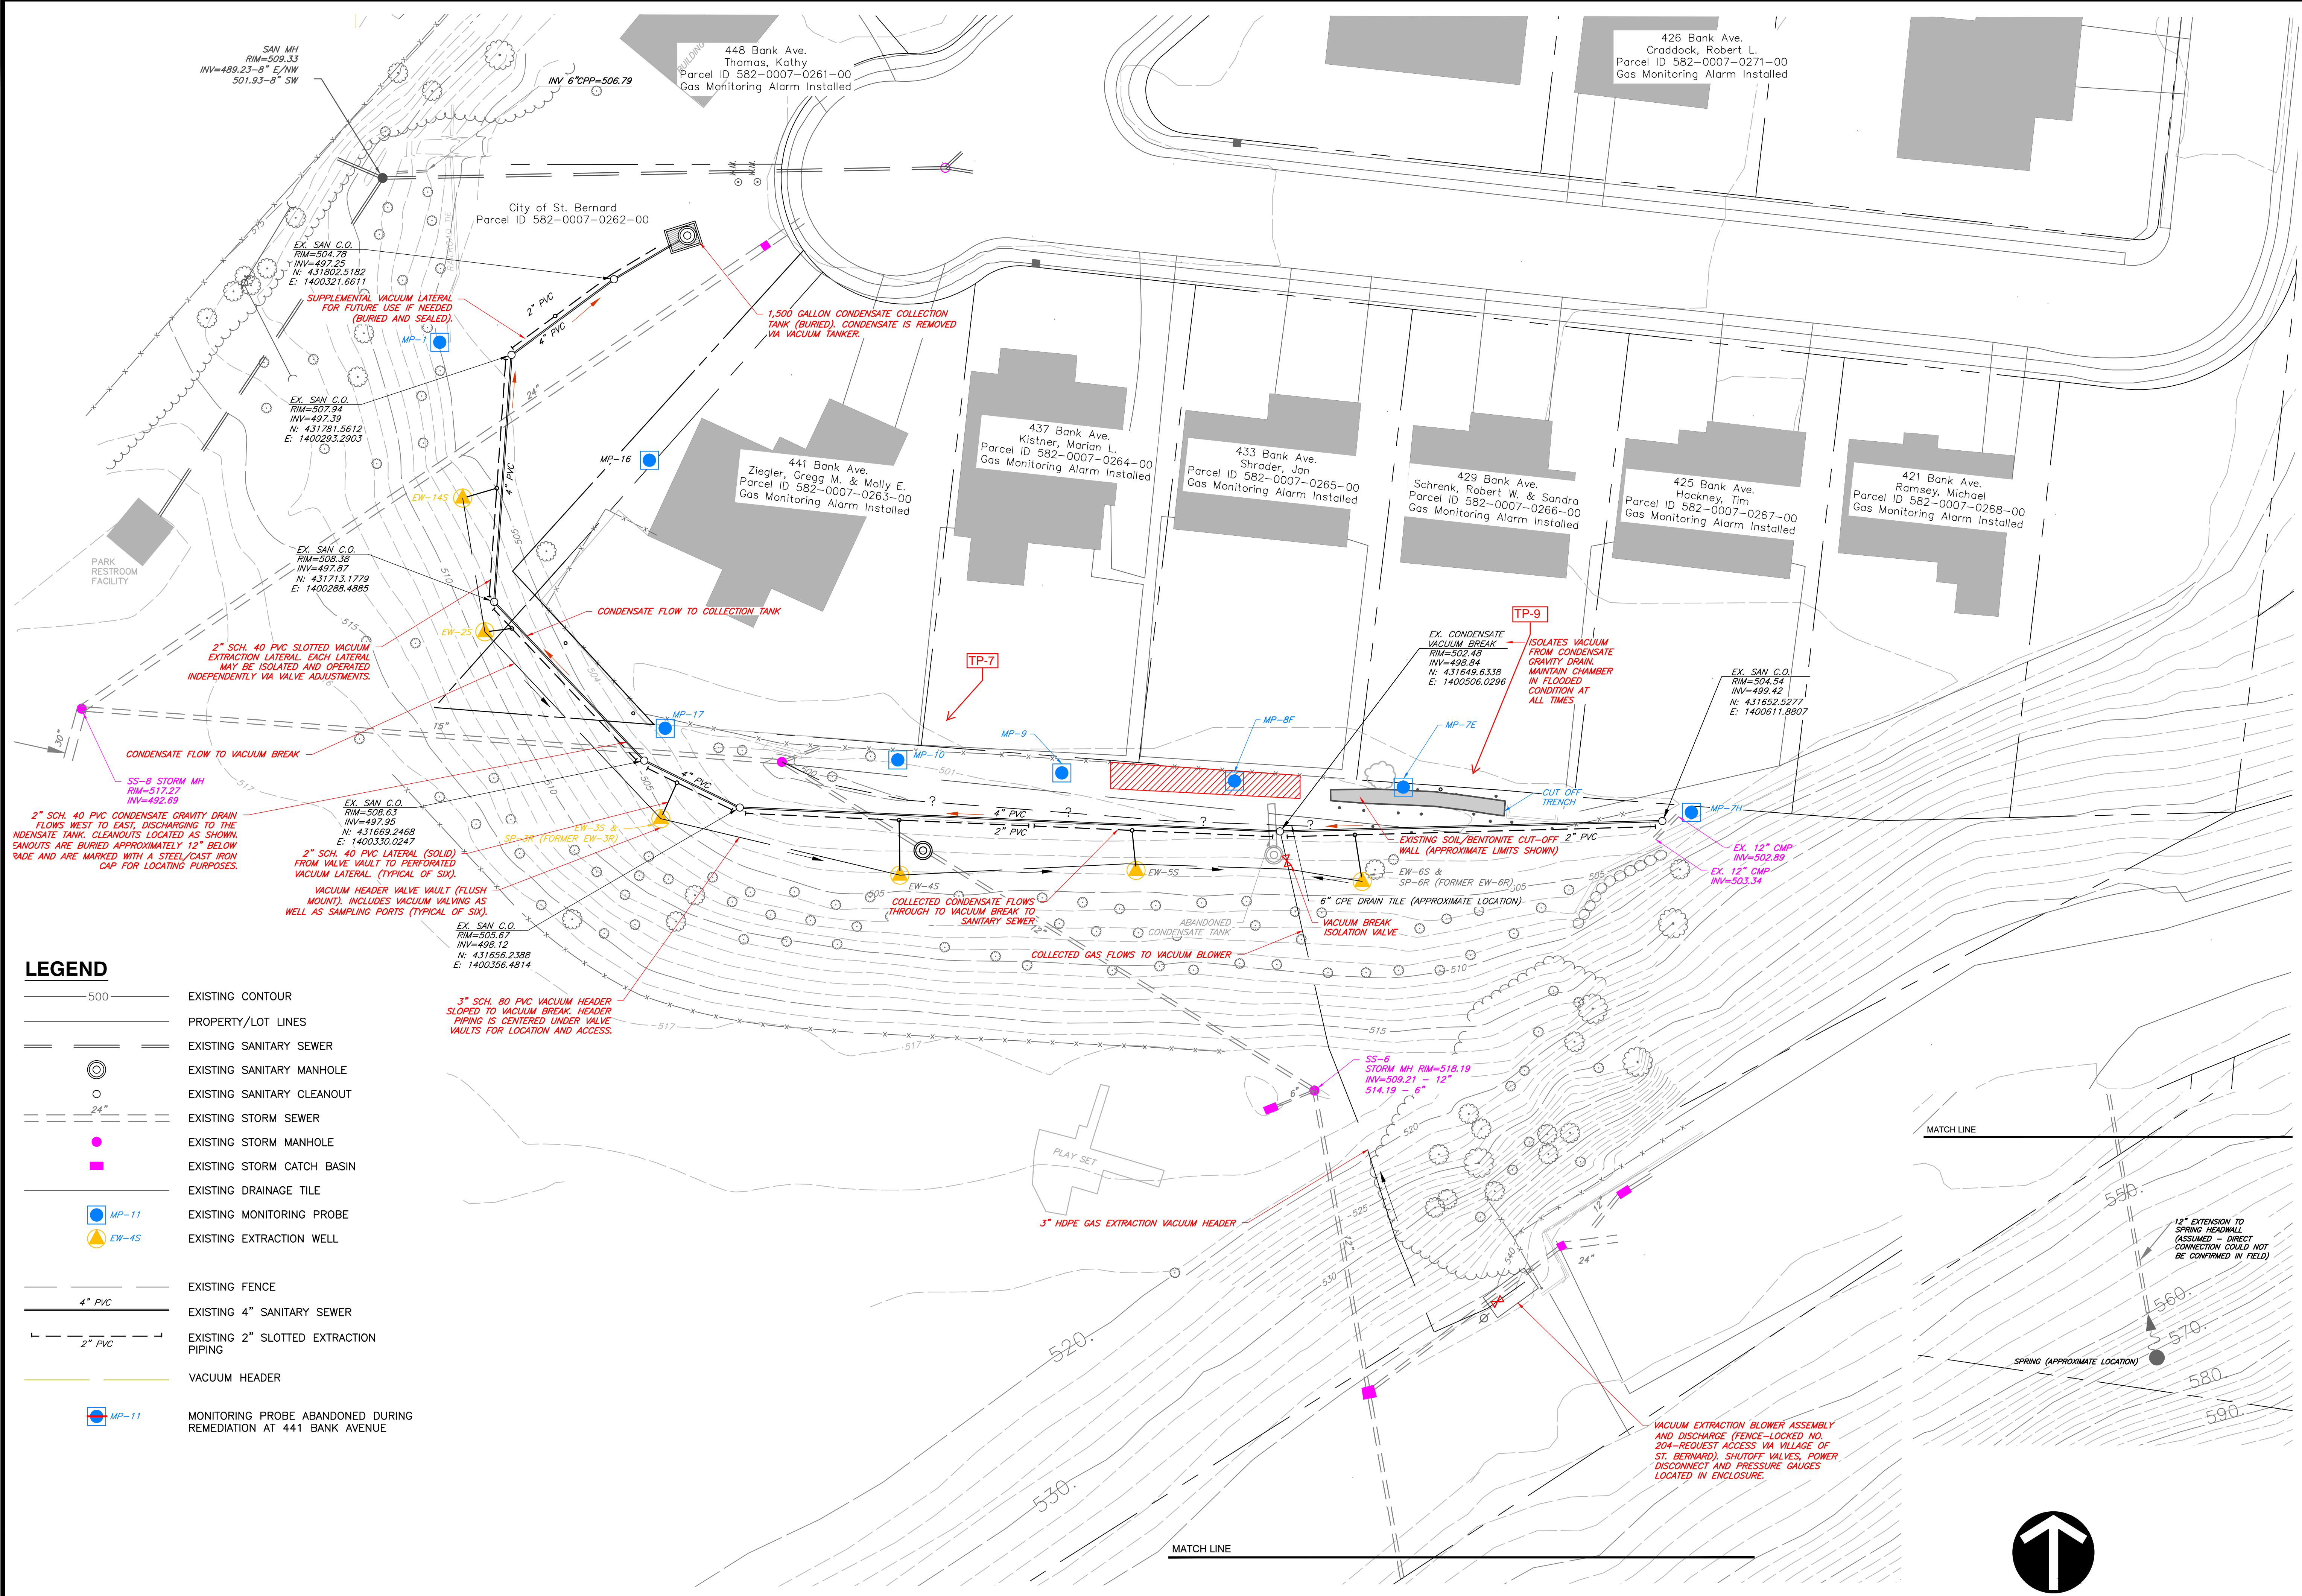
CK. BY	
DESCRIPTION	
REV. DATE	
SHEET TITLE	MONITORING NETWORK
PROJECT TITLE	ST. BERNARD LANDFILL VILLAGE OF ST. BERNARD, OHIO
CLIENT	VILLAGE OF ST. BERNARD 110 WASHINGTON AVENUE ST. BERNARD, OHIO 45217
CADD FILE:	FIG 5
DATE:	SEPTEMBER 2014
SCALE:	AS SHOWN
DRAWING NO.	FIG 1

The absence of pressure at MP-10 indicates that there is no driving force that could cause gas migration over a significant distance. The methane detected at MP-10 is likely either a localized concentration or is present due to migration driven only by a concentration gradient/diffusion. Given this condition, it is unlikely that sufficient methane to present a risk to human health and safety will reach the residences. The residences adjacent to the landfill (excluding the Schrenk residence) have gas alarms and there have been no reported detections of landfill related combustible gas, indicating that these short term detections of combustible gas as has occurred at MP-10 do not represent a risk to the residences. At this time, no further remedial actions are proposed.

The collection and control system was adjusted to apply additional vacuum to the segment in the vicinity of MP-10, specifically the segment monitored by EW-4S. This was done by reducing vacuum on the other selected segments in the system.

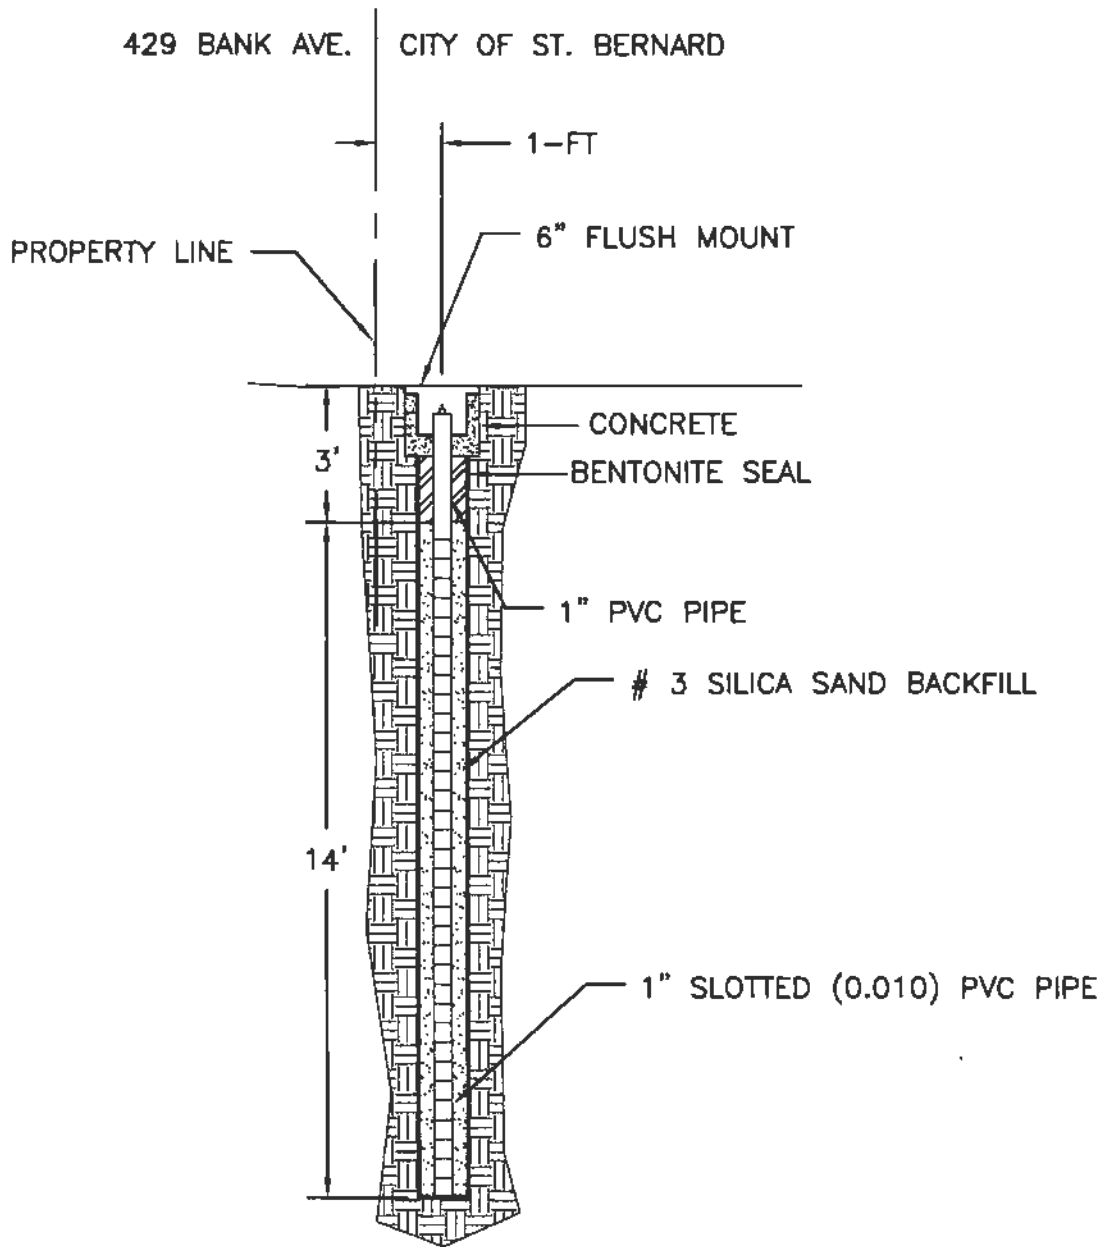
MP-7E

The results of the contingency monitoring performed to date are included in Attachment B. The most recent monitoring was performed on September 18 and 21, 2017. Four rounds of reading below 5 percent were collected over a two-week period at MP-7E. This meets the criteria for terminating contingency monitoring. Combustible gas concentrations above the compliance threshold were detected at MP-10. With the discontinuation of contingency monitoring at MP-7E, this is the final 30-day report for this probe.
