SCS ENGINEERS

December 18, 2017 File No. 23212007.05

Subject: Village of St. Bernard Landfill Request to Remove MP-10 from the Monitoring Network

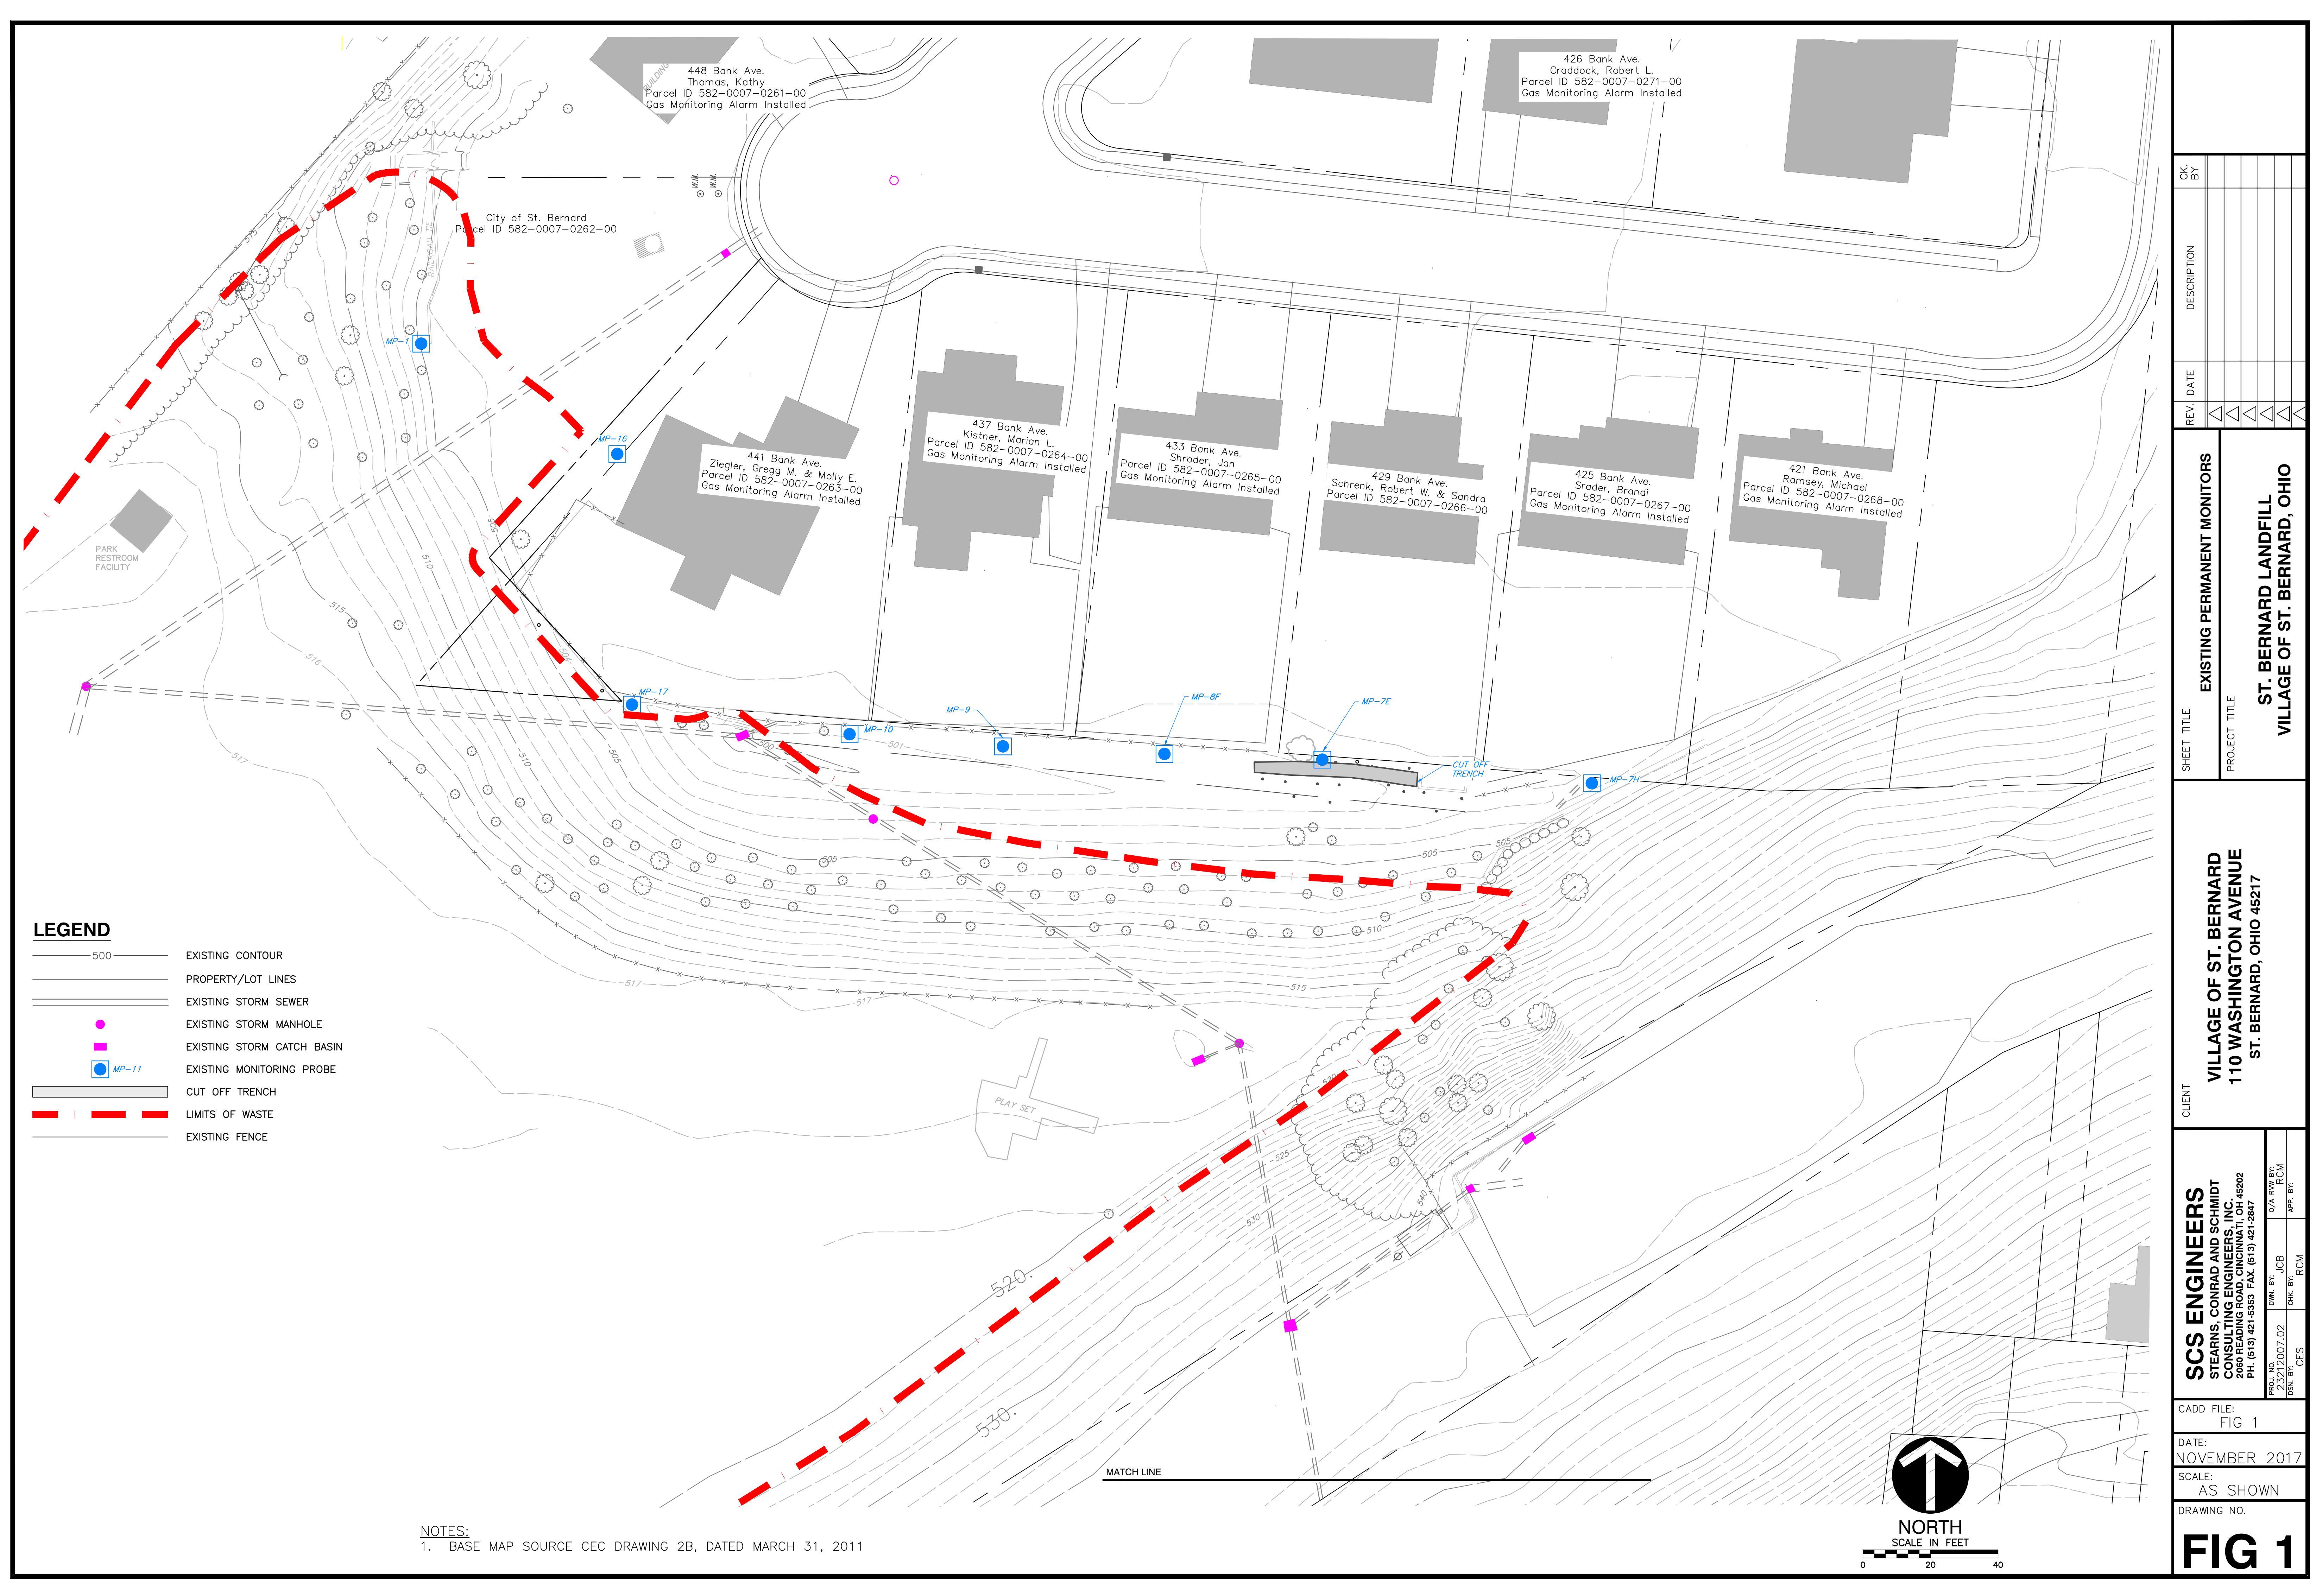
The location of MP-10 is shown on Figure 1 in Attachment A. It is near the boundary between the properties at 441 and 437 Bank Avenue. A boring log with the as-built construction of MP-10 is presented in Attachment B. MP-10 is screened from approximately 2 to 12 feet below ground surface. The materials screened include fill from 5 to 11 feet below ground surface. As can be seen in Figure 1, MP-10 is located near the waste limits. MP-10 is also near a storm water inlet that provides for a concentration of storm water flow in the area and creates a wet, boggy condition at times due to the increased infiltration in the vicinity of MP-10.

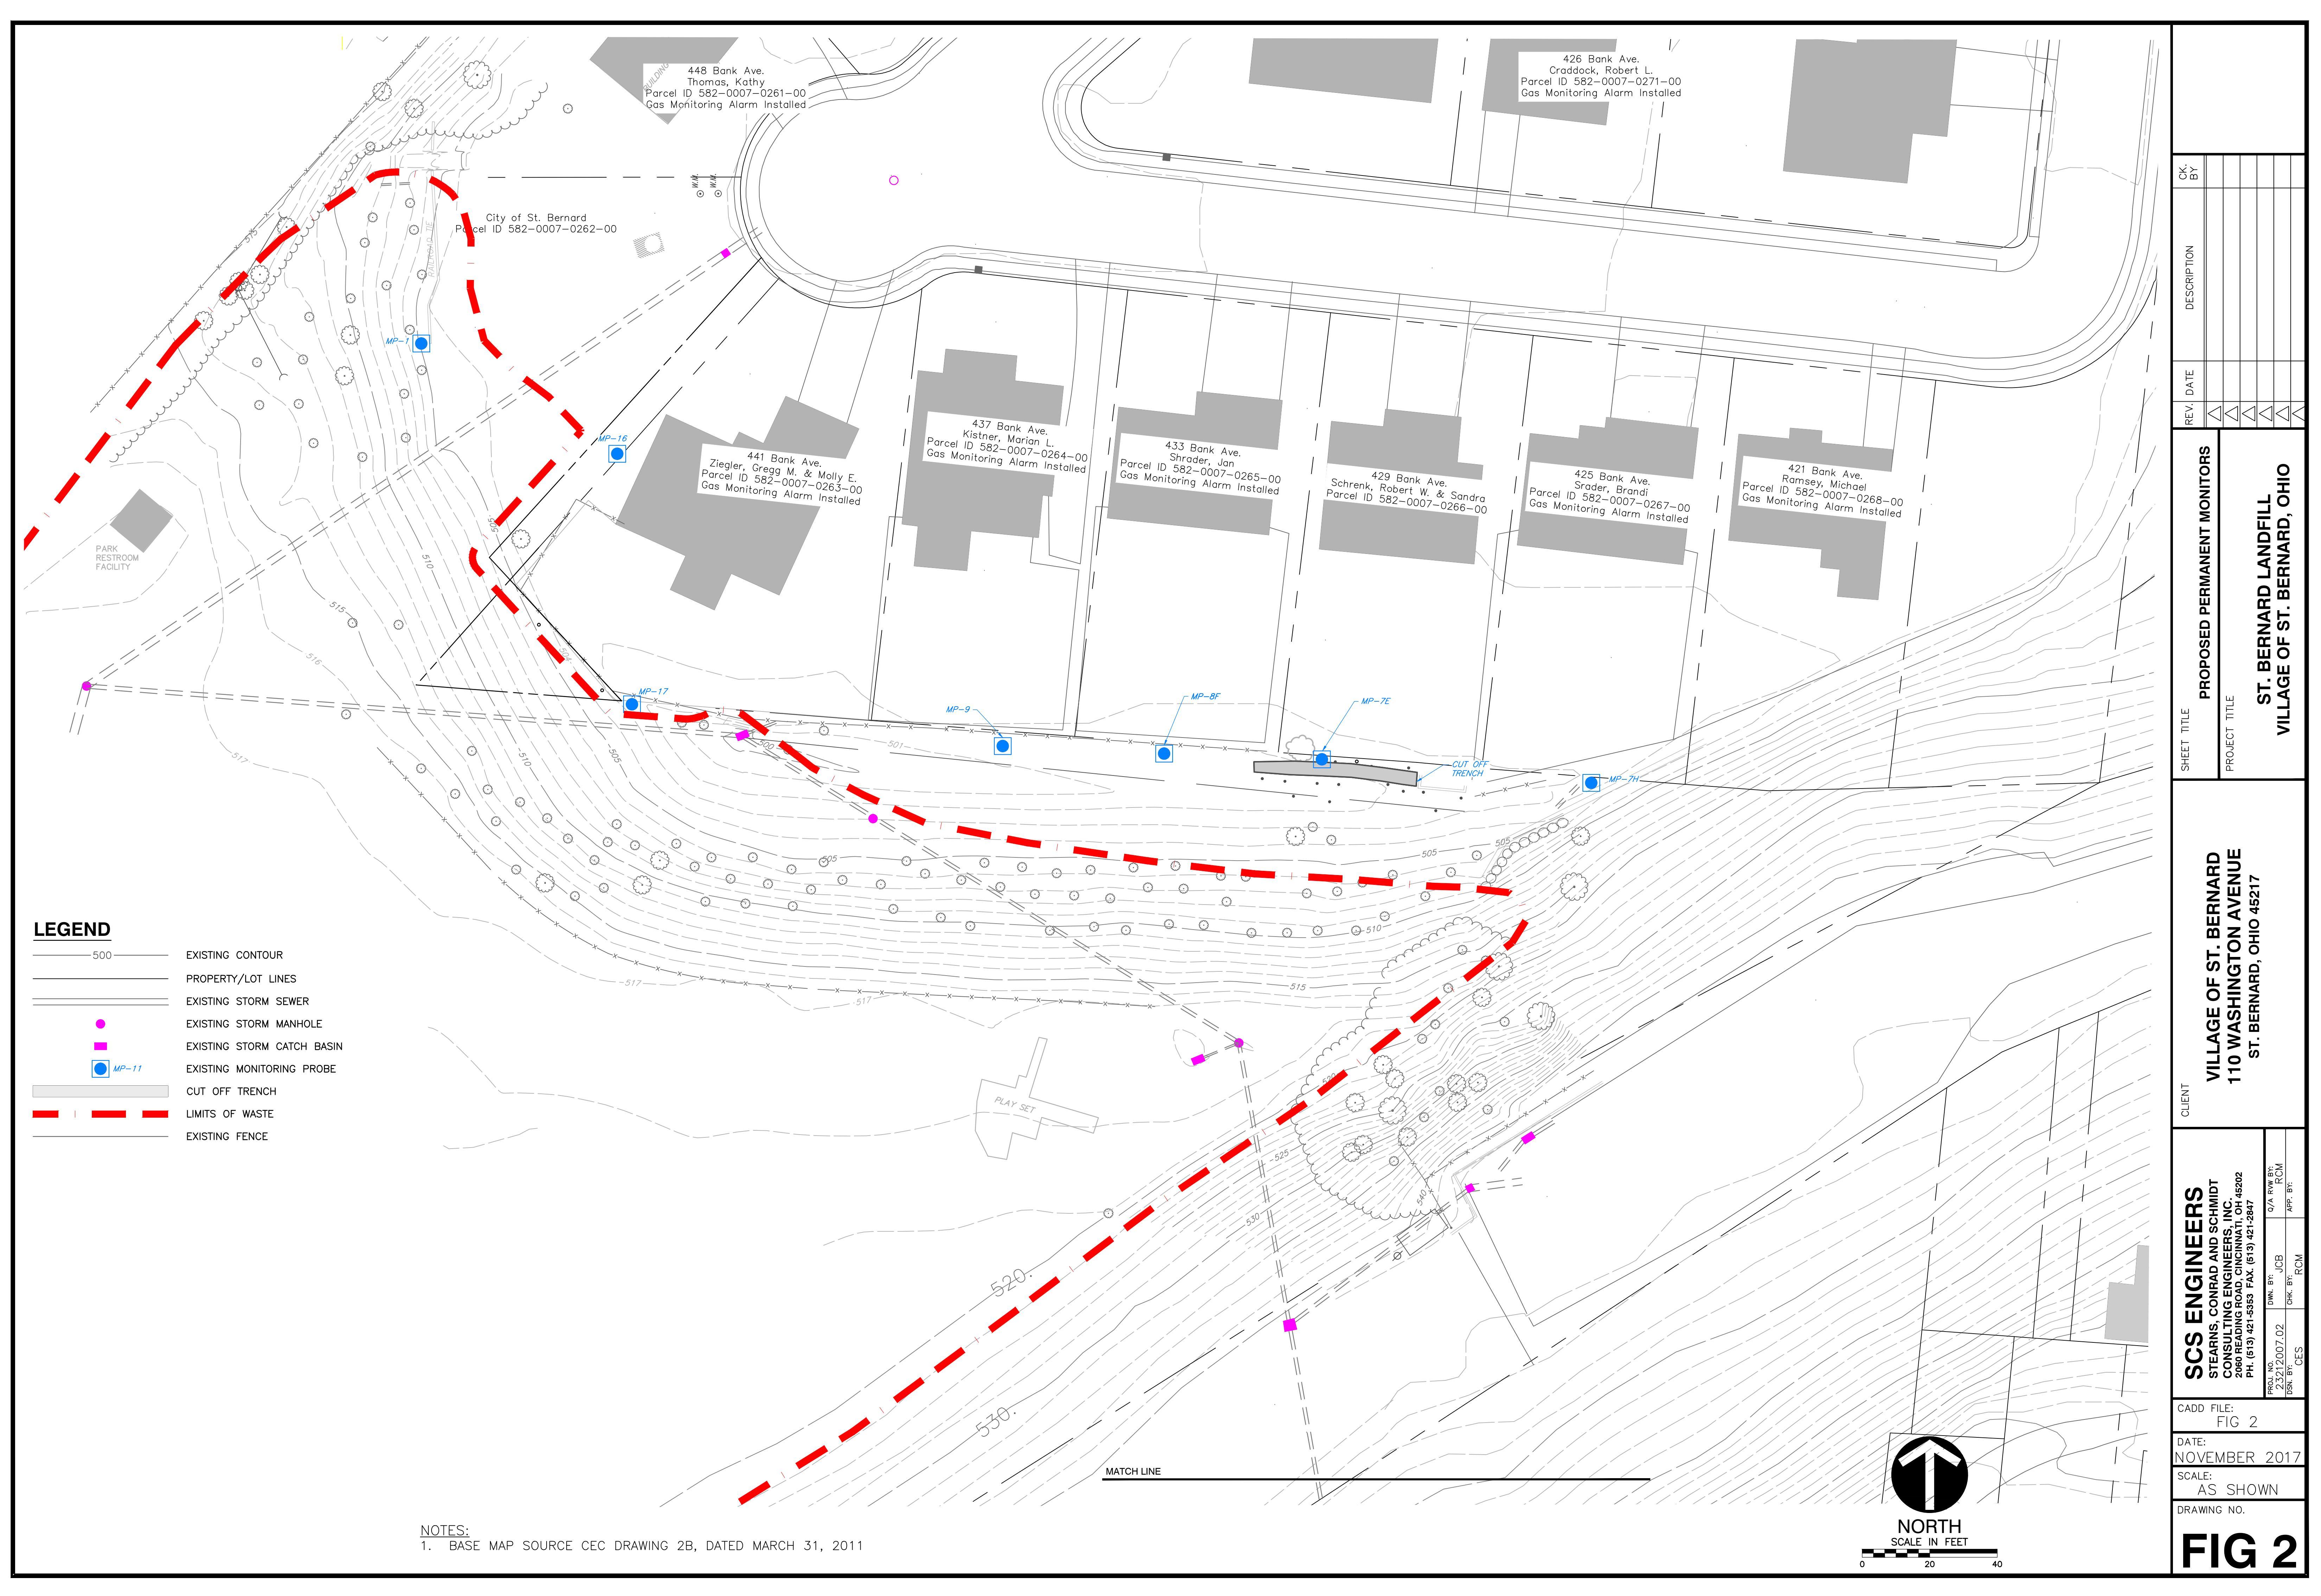
The monitoring network without MP-10 is shown on Figure 2 in Attachment A. By removing MP-10, an average spacing between the probes would increase only slightly from 61 to 73 feet and the maximum distance between probes would increase only slightly from approximately 83 to 113 feet. There remains at least one probe between the landfill and each of the residences that abut the landfill.

The combustible gas occasionally detected at MP-10 is a localized phenomenon that does not present a threat to the nearby residences. It is SCS's professional opinion that the proposed monitoring network, excluding MP-10, provides adequate protection for the residences adjacent to the closed St. Bernard Landfill. If the removal of MP-10 from the monitoring network is approved, it will no longer be monitored and will be abandoned as soon as practical in early 2018.
