Subject: Village of St. Bernard Landfill
Revised Explosive Gas Monitoring Plan

EXPLOSIVE GAS MONITORING PLAN CLOSED ST. BERNARD LANDFILL

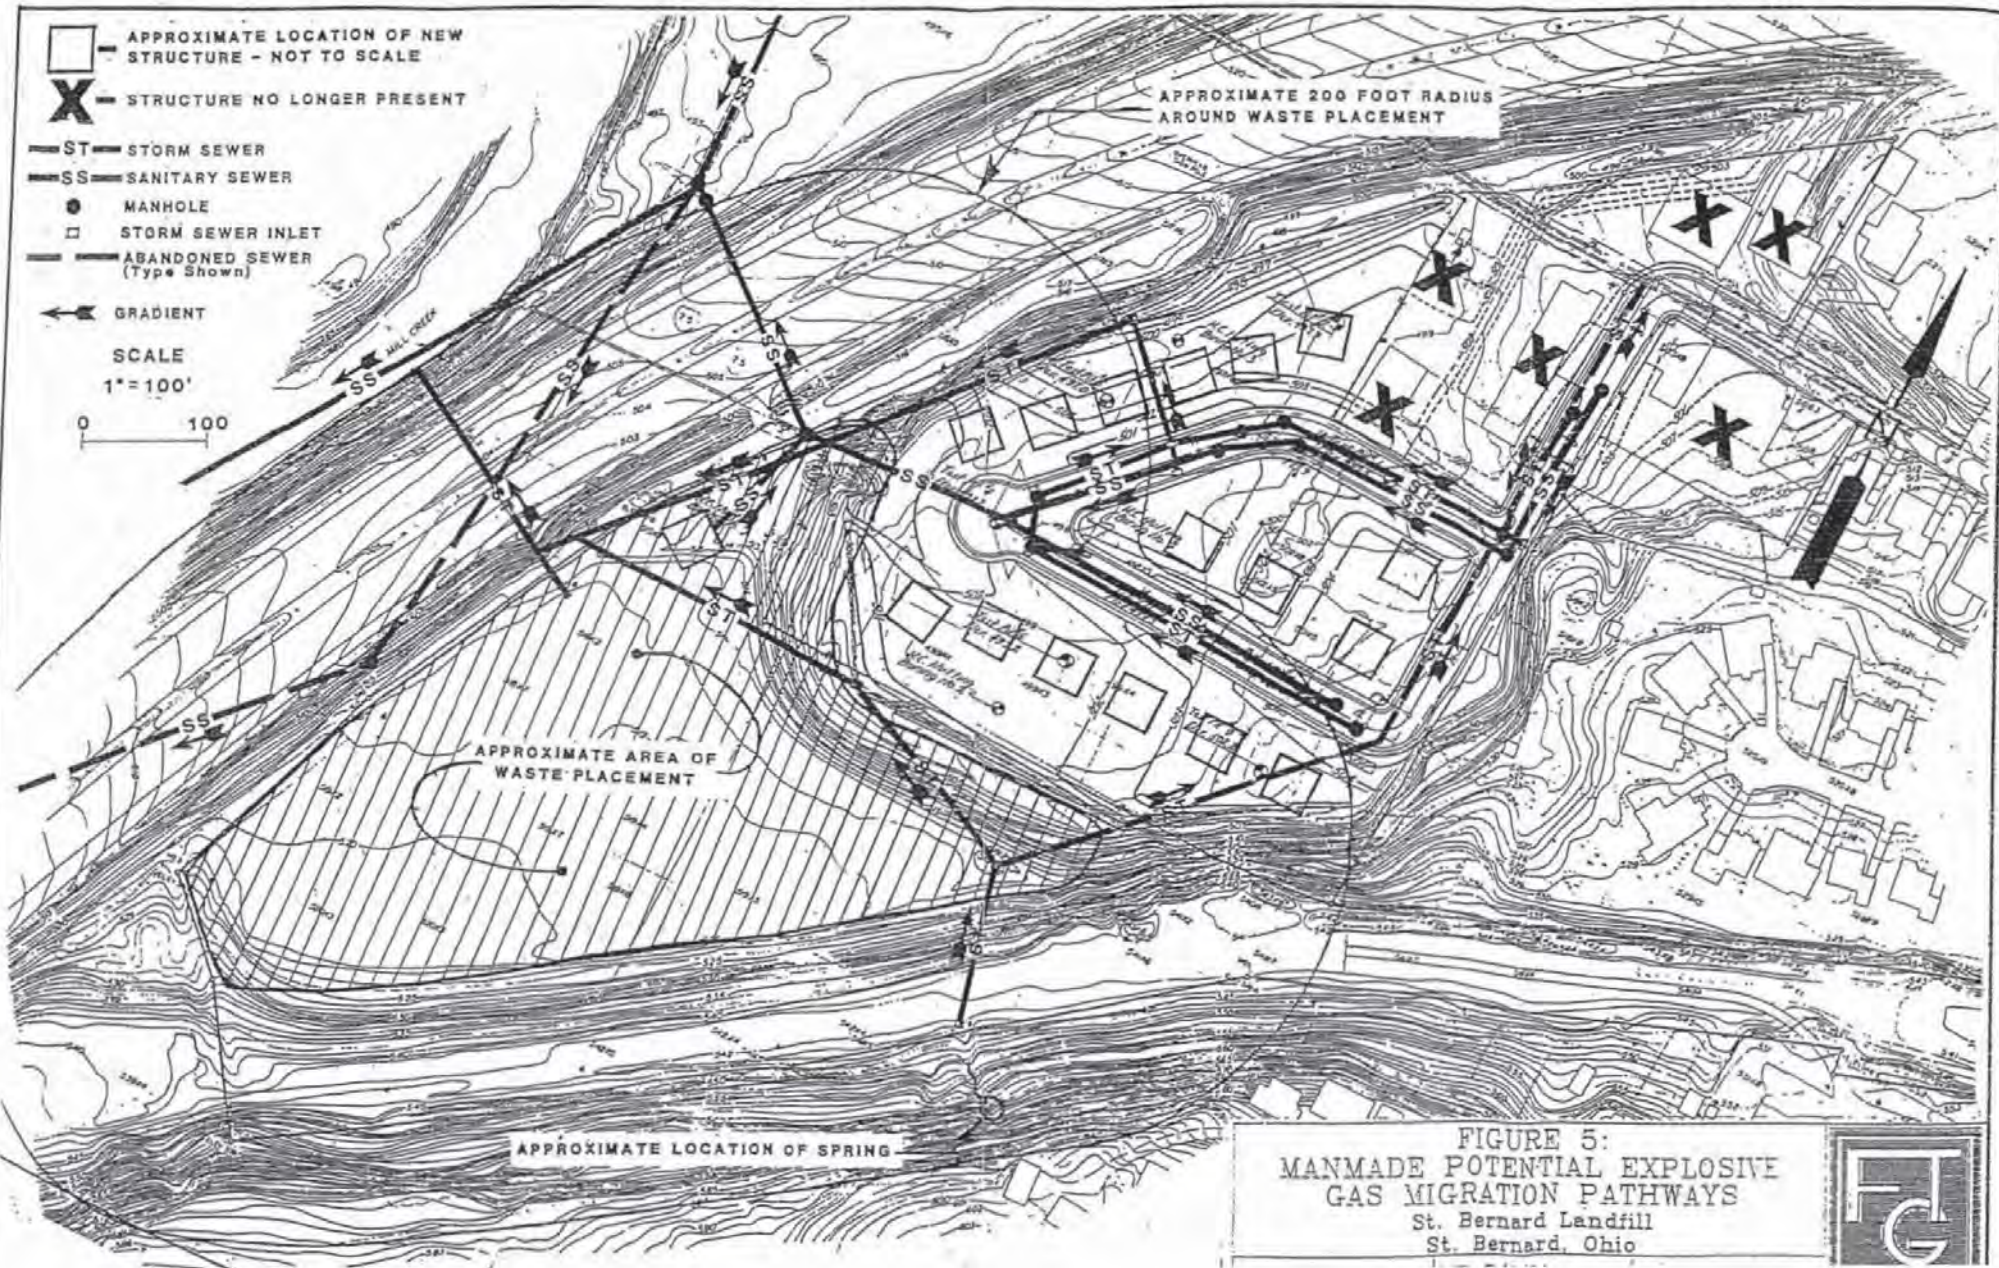
FIGURE 5. MAN MADE MIGRATION PATHWAS

June 18, 2014. SCS incorporates this figure in full and unedited from the original source: Foppe Thelen, Explosive Gas Monitoring System Design, October 1991.

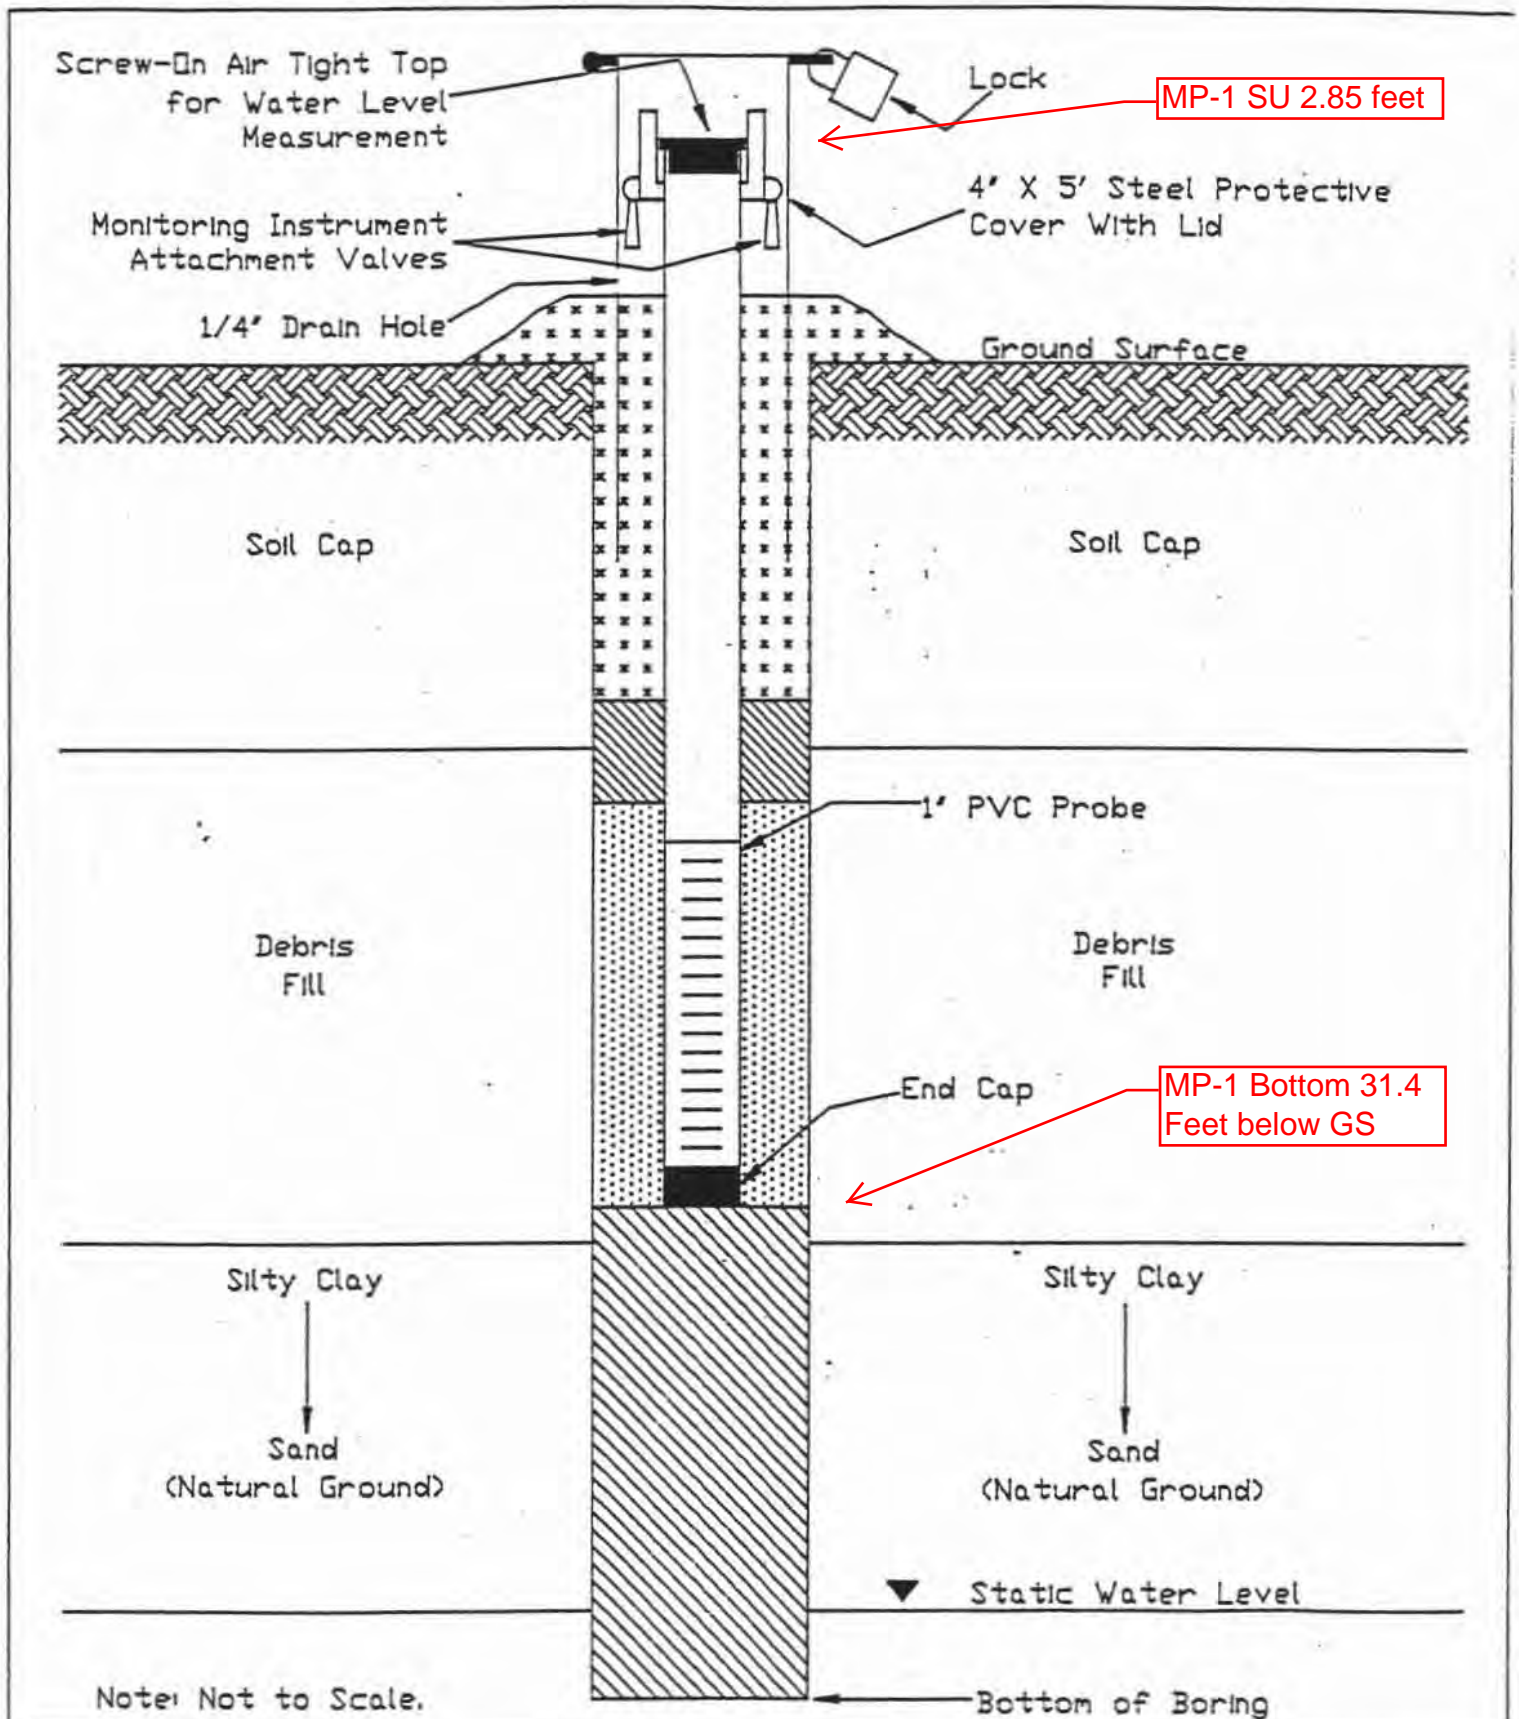
FIGURE 11:
GENERALIZED MONITORING PROBE

Legend	
	Cement
	Sand Pack
	Bentonite Seal

Permanent monitors were typically screened from two to three feet below grade to the target depth of the permanent monitor, typically the top of the native soil beneath the soil fill. The target depths were adjusted in the field depending on the conditions encountered. For example, if the water table was encountered within the target depth, the bottom of the screened zone was raised so that the permanent monitor would not extend into the seasonal low water table. The probes are constructed of 2-inch or 1-inch I.D. schedule 40 PVC riser and machine slotted screen. The annulus around and above the screen was backfilled with coarse sand. A bentonite seal or concrete seal was placed above the sand. The remaining borehole annulus was backfilled with concrete.
