December 3, 2021
File No. 23212007.09

Subject: Village of St. Bernard Landfill
MP-9 Contingency Monitoring 3rd 30-day/End of Contingency Monitoring Report

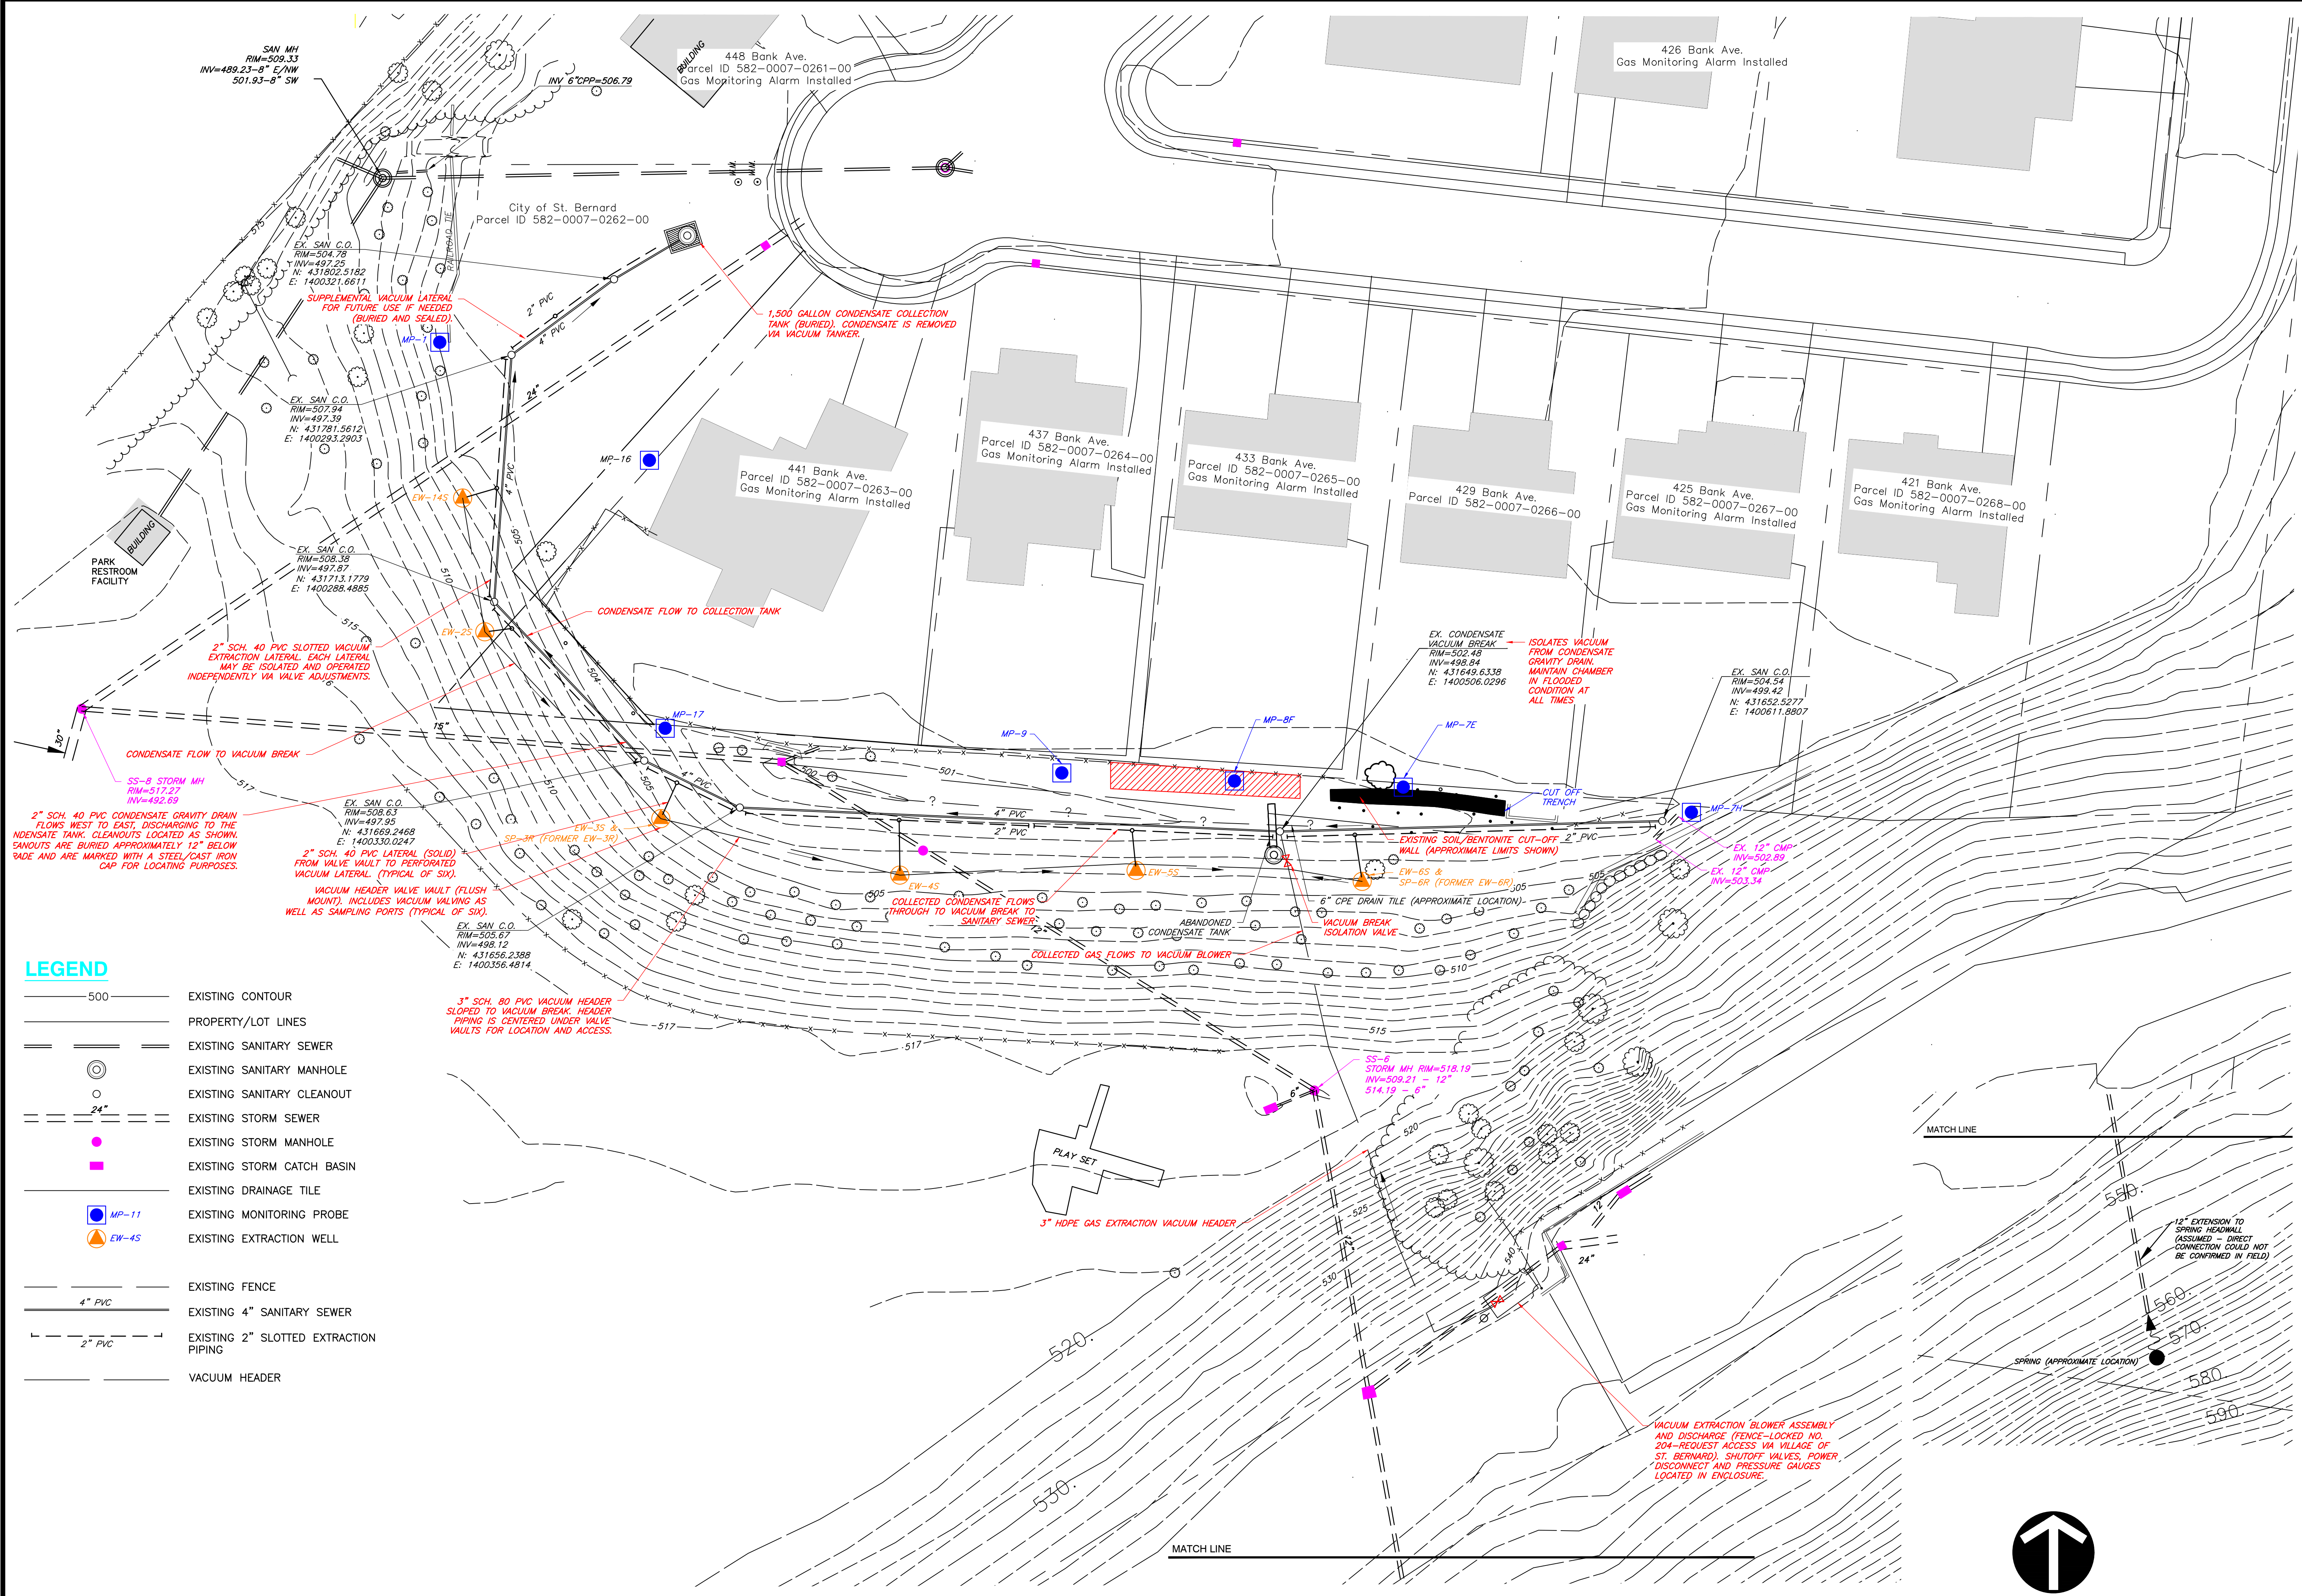
CK. BY	
DESCRIPTION	
REV. DATE	
SHEET TITLE	MONITORING NETWORK
PROJECT TITLE	ST. BERNARD LANDFILL VILLAGE OF ST. BERNARD, OHIO
CLIENT	VILLAGE OF ST. BERNARD 110 WASHINGTON AVENUE ST. BERNARD, OHIO 45217
SCS ENGINEERS	STEARN, CONRAD AND SCHMIDT CONSULTING ENGINEERS, INC. 2060 READING ROAD, CINCINNATI, OH 45202 PH. (615) 421-5583
CADD FILE:	FIG 4
DATE:	AUGUST 2021
SCALE:	AS SHOWN
DRAWING NO.	FIG 1

Following meeting the criteria for ending contingency monitoring, a report summarizing the contingency monitoring will be submitted. This letter serves as the third 30-day report and the end of contingency monitoring summary report. The 30-day submittal date is December 7, 2021. Submittal of this report on December 3, 2021, (within 30 days after the last 30-day report) fulfills the requirements of the applicable rule, OAC 3745-27-12 (E)(5)(g)(ii). A site map is presented as Figure 1 in Attachment A.
